# CRYSTAL BEACH POOL RENOVATION

*400 W Vaughn Drive, Madison, IN*

## Condition Summary & Recommendations

*April 11, 2022*

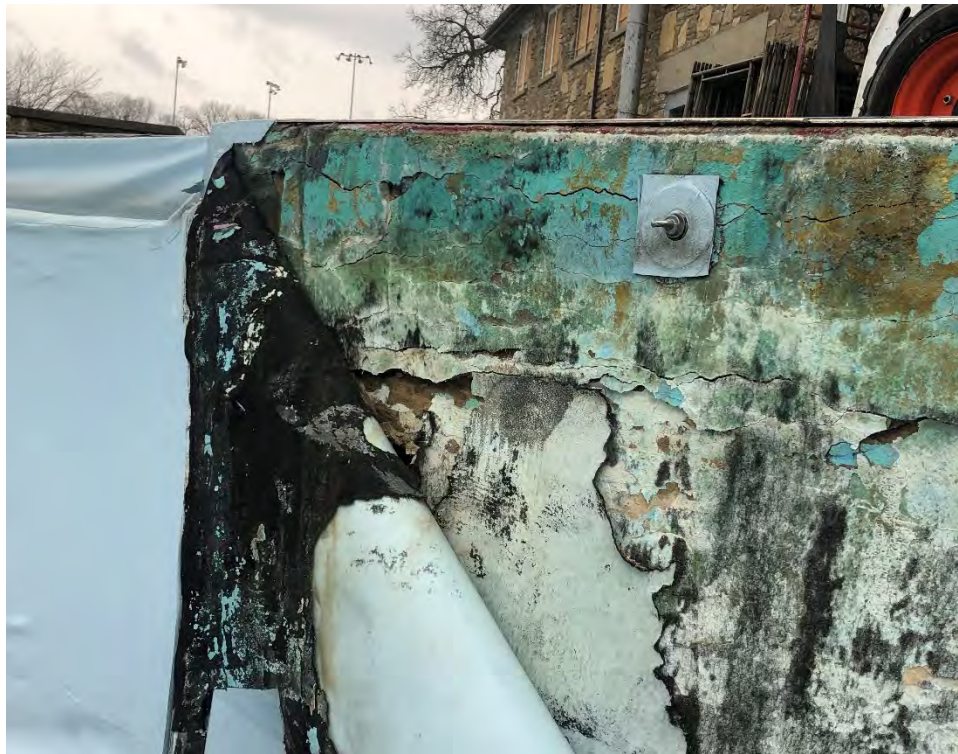
***Issue 1:*** Cracks and spalling at North wall of pool indicate potential loss of integrity.

1. Demolish and re-build the North wall. The concrete has reached the end of its useful and reliable service life; a retrofit would not ensure that the proper strength is provided *and* be less expensive or completed sooner. Potentially, a new wall could be poured in front of the existing, abandoning the current wall in place. This could be supported by a new retaining wall foundation system, or anchored with soil nails back to solid grade behind the wall.

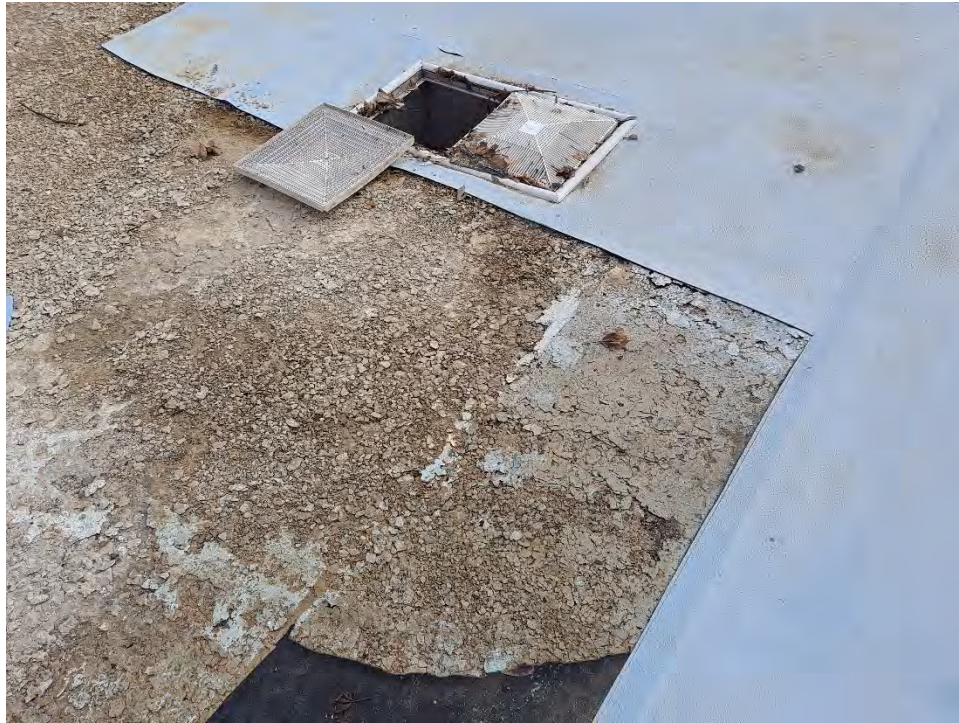
***Issue 2: Spalled concrete top layer indicates freeze-thaw damage and moisture intrusion into basin structure.***

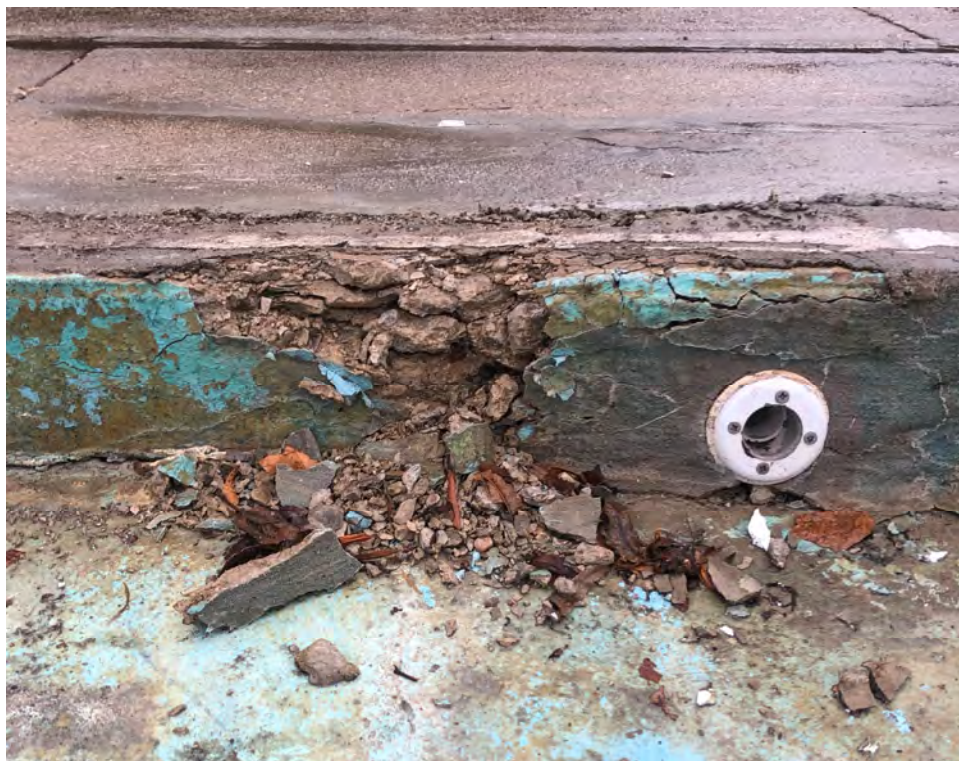
***Issue 3: Damaged curb at curved zero-entry edge of pool***

3. Add adequate surge tank(s), located behind curved wall section with former portholes.
4. Replace curb, perimeter deck, and gutter for proper zero-edge and drainage.

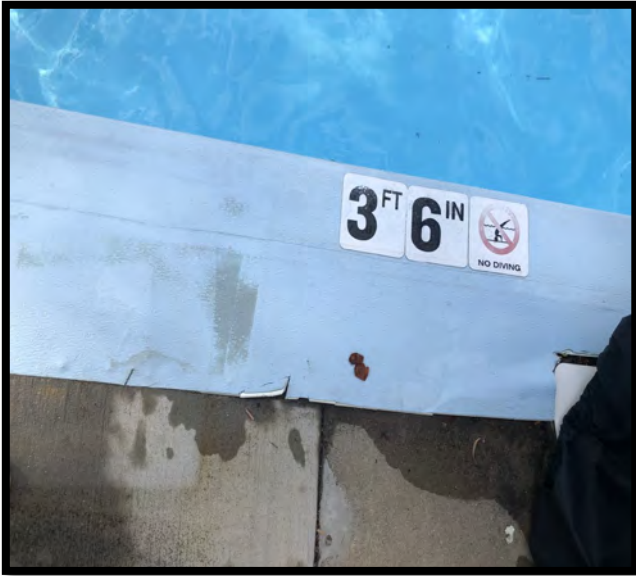
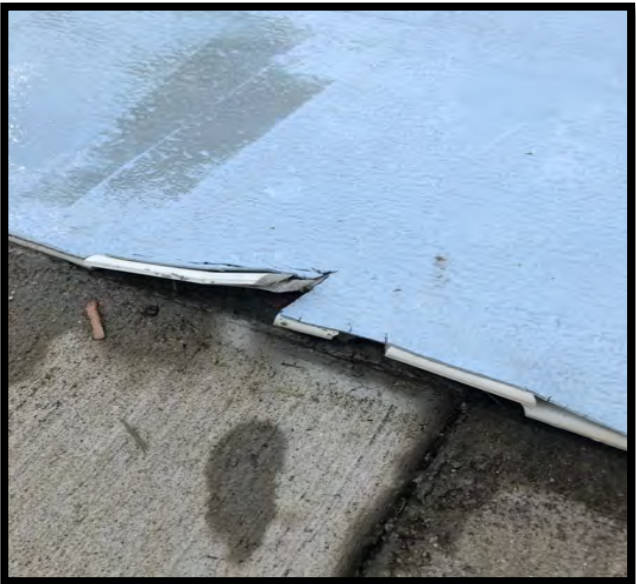
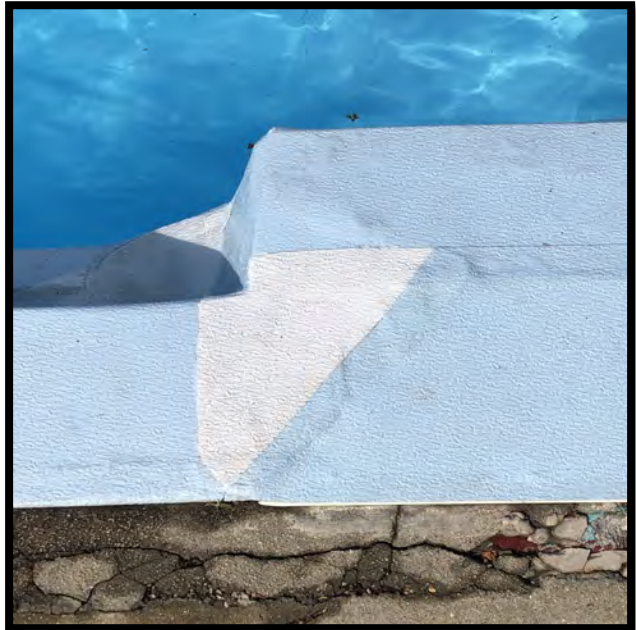
**LEISURE POOL FINISH**

At the time of my review, the leisure pool was full of water, and a surface inspection was impossible. Observations from the pool edge along with conversations with the pool operator are the basis of the findings noted below.

The exposed pool wall located on the south side of the pool within the lower level of the bathhouse had clear signs of the pool leaking. Cracks in the concrete pool wall has water weeping through the cracks. This could be contributed to a fractured pipe, but until the piping is pressure tested, it is unclear where the water is coming from. With the age of the liner and the current condition seen during my inspection, some or all of the leakage can likely be contributed to a failing liner.

Replace the current pool liner with a new liner installed by a qualified contractor.

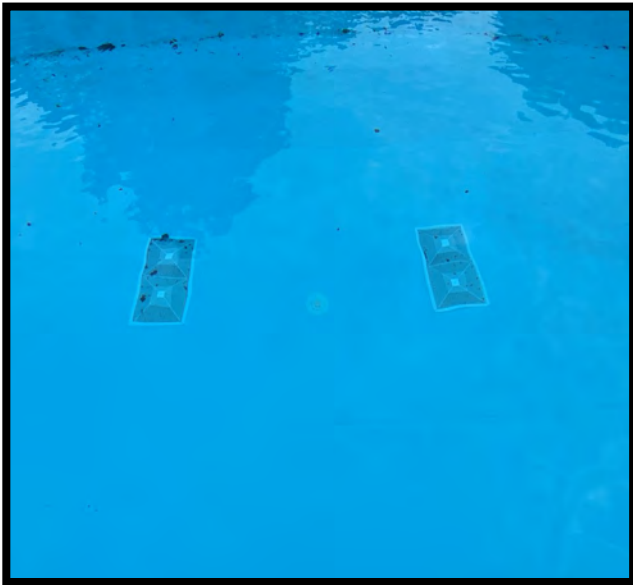
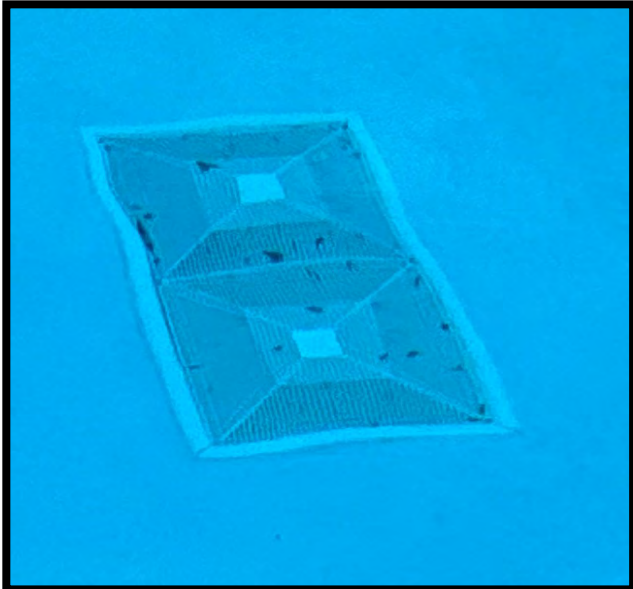
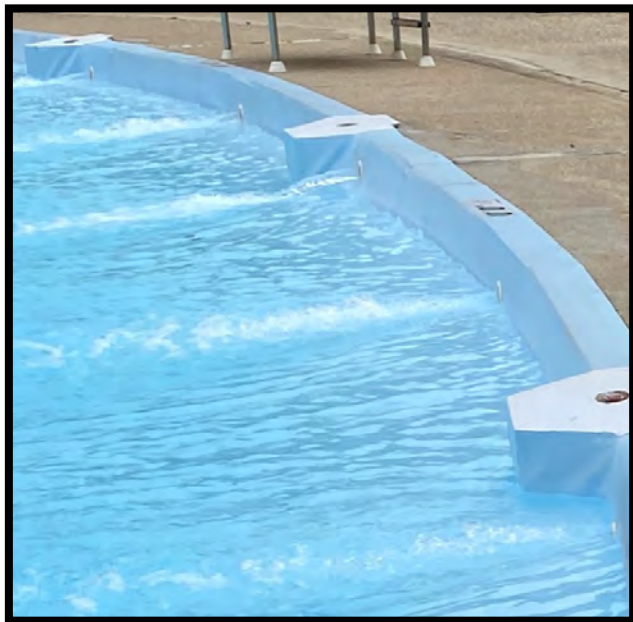
**LEISURE POOL MAIN DRAINS & INLETS**

At the time of my review, the pool was full of water; therefore, a detailed review of the main drains was impossible. It appears the main drains are 24" x 48" with two covers installed on each main drain. Confirmation of VGB (Virginia Graeme Baker) compliance could not be verified. All main drains installed in public swimming pools in the United States must be VGB compliant by law. Additionally, compliance must be documented, and the paperwork must be on file at the designated facility.

“New” VGB compliance regulations are soon to be enacted (Nov. 2020) for all pools. Law requires all main drains of existing facilities must meet the regulations noted below. Verification of the 1.5 D could not be verified. Additionally, date stamps on the existing sump covers also could not be verified. This verification is also required.

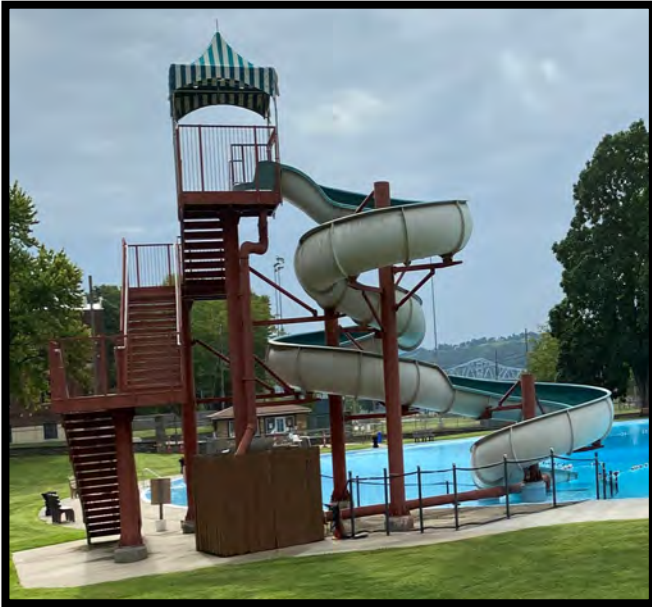
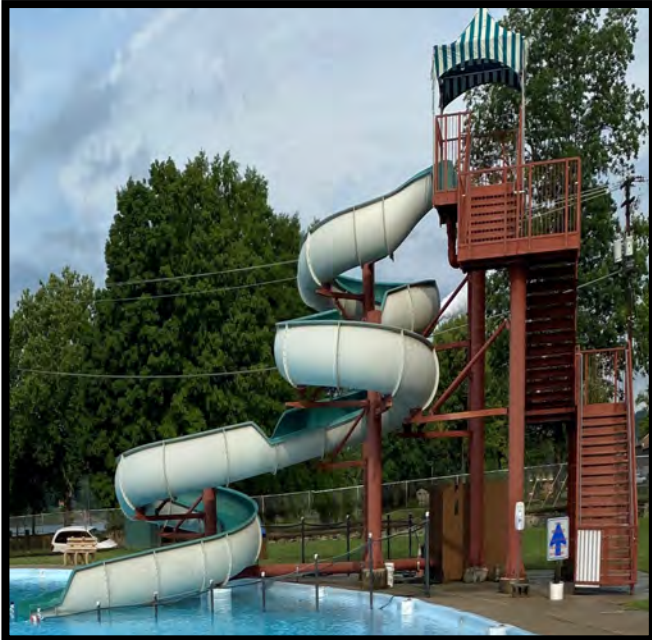
### SWIMMING POOL - WATER SLIDE

The painted surfaces of the steel support columns, extension arms and ladders, and stair treads are severely faded, but fictionally in good condition. The slide platform is starting to show corrosion at the support beams on the underside of the platform (see picture, lower left). Although this is currently a minor concern, repairs are justified to prevent further corrosion.

The water slide riding surface requires attention. The flange joints where the slide flume pieces are interconnected are all missing the caulk fill within the seam surface. Typically, the caulk needs to be replaced every 2 to 3 years. Additionally, the riding surface is severely faded and rough in spots. The slide owners manual notes that the slide surface needs to be waxed at the beginning and end of each swim season.

Repair Slide Platform Corrosion

Epoxy paint the water slide structural steel

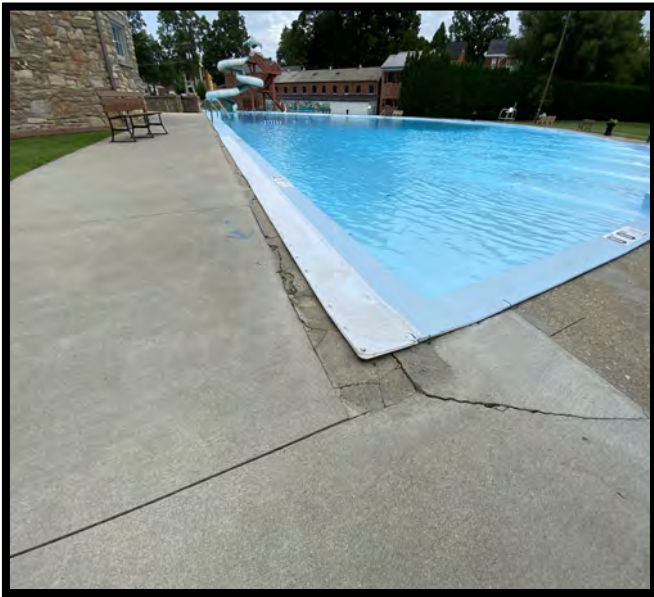
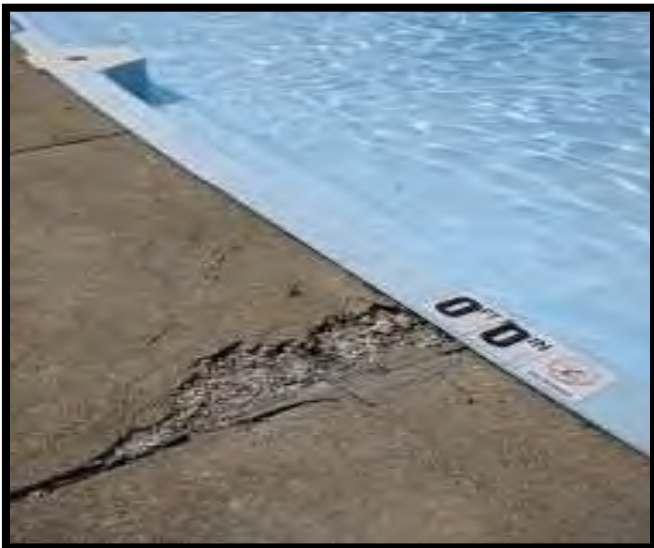
### POOL DECKS

The pool deck directly in front of the entryway from the bathhouse and the walkway headed eastward in front of the bathhouse, along with the pool deck around the water slide, is new from the 2006 renovation. The remainder of the pool deck is original to the 1939 construction.

The original pool decks are in very poor condition. A majority of the original pool deck has uneven delaminated surfaces, structural cracks, and failed patchwork. Additionally, the pool deck surrounding the ark portion of the pool has an open gutter trench as part of the concrete surface (see picture lower-left). At entry locations, the open concrete trench drains into the pool, which conflicts with current local (675 IAC 20-3-4 (b) (4)) and national pool codes and design standards. Pool decks are required to drain away from the pool deck.

Replace the original pool deck around the perimeter of the pool. Add code required deck drainage.

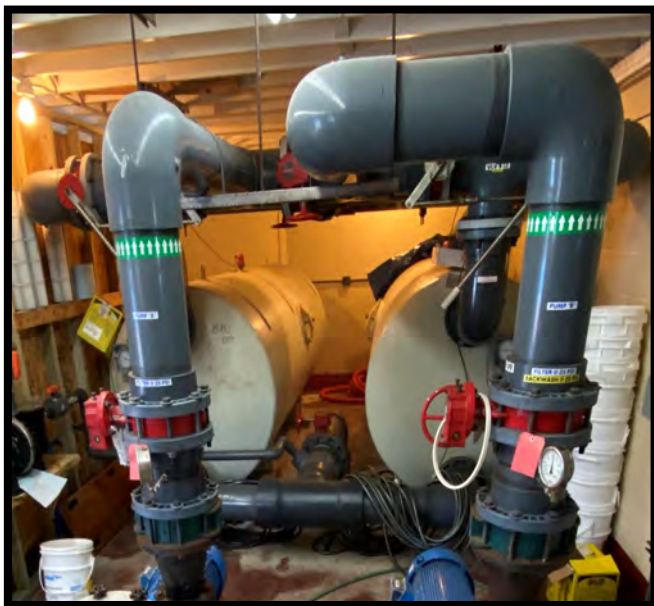
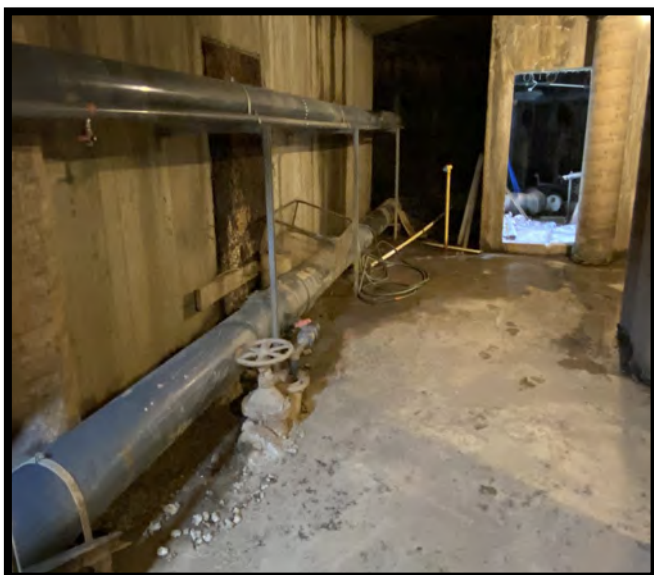
**LEISURE POOL ABOVE GRADE—FILTER ROOM LOWER LEVEL EXPOSED PIPING**

Pipe hangers in the basement show surface rust and corrosion. Currently, there is no need for replacement, but it is important to lubricate the pipe hangers to prevent the advancement of corrosion. If the basement of the building is to be renovated, pipe hanger renovation is recommended.

The check valves located on the discharge side of the concentric reducers are incorrectly placed. Check valves are required to be located post throttling valve and require to have at least five pipe diameters before and ten pipe diameters after the check valve before any fittings or valves. This is a manufacturer's recommendation.

The Blue-White digital flowmeter is currently showing 0 flow. This needs to be repaired or replaced to provide flow monitoring per code. Additionally, the flowmeter needs to be relocated before the tee splitting the feed east and west. If a new chemical controller is added to the system, it is suggested to tie the flowmeter to the chemical controller so that flow can be monitored from the main level of the building.

Under the current conditions, budget pipe hanger/support replacement in the basement within the next 2 to 3 years.

Replace Blue-White Digital Flowmeter with a Signet Magmeter with a Remote Digital Readout

Relocate the check valves as required by the manufacturer.

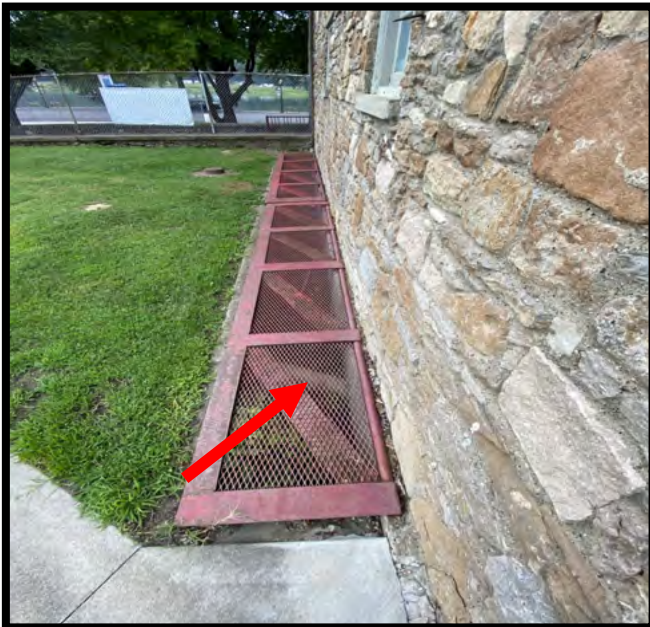
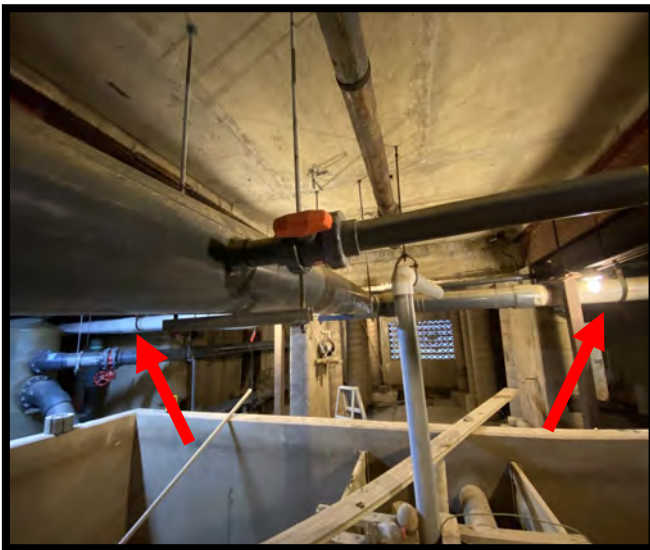
**LEISURE POOL BELOW GRADE PIPING**

Pool return piping is routed downward from the pool filters through an opening on the first floor into the basement. The piping branches at a tee directing the water east and west, leaving the basement at open spaces as shown in the picture on the top left. Piping transitions from sch. 80 to 40 at the tee in the basement. As the piping exits the basement, it is routed underground behind the pool deck on the south side of the pool. As the return piping extends east and west, it turns north and extends around the circumference of the pool. The pool deck on the east, west, and north sides of the pool is original; therefore, I assume most, or all of the piping in these areas is original. No drawings exist indicating the replacement of this piping.

The pool piping embedded in the pool concrete is cast-iron. There is a likelihood that the below-grade piping on the east, west, and north sides of the pool is also cast-iron, which is suspect due to its age (80 years) and tendency to fail due to the corrosive nature of chlorinated water.

As noted previously in this report, the current quantity of pool inlets does not meet current local or national health code requirements. Indiana Health Codes require a pool of this size (19,868 sq. ft.) to have a minimum of 40 inlets with a maximum allowable flow of 40 GPM per inlet. Current design standards require 20 to 30 GPM per inlet, which would result in a total of 55 inlets. During my review, I counted less than 35.

Pressure (hydrostatic) test all below-grade pool piping. Piping should withstand a min pressure of 25 to 30 psi.

Replace below grade pool piping on the east, west, and north sides of the pool. Add additional inlets to meet current health code requirements.

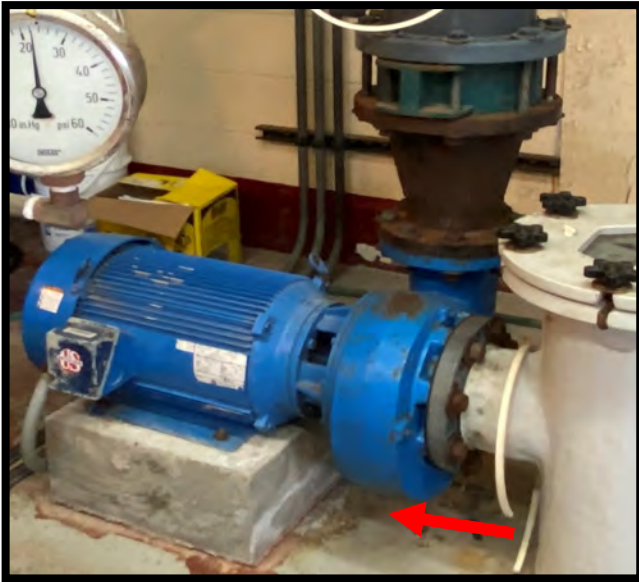
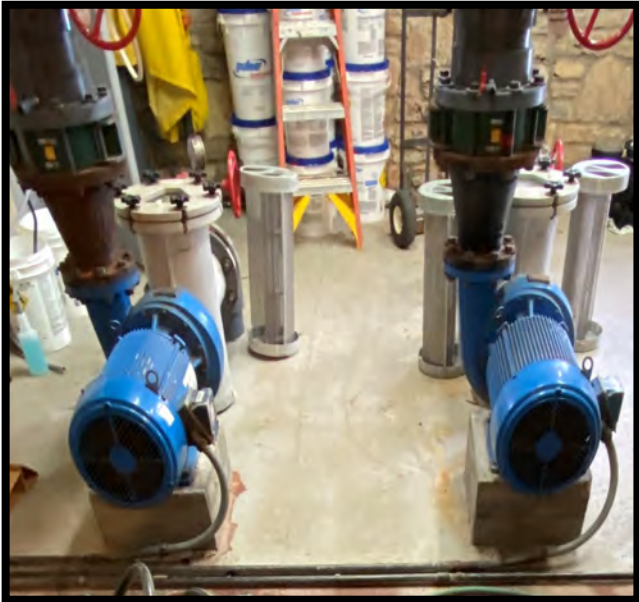
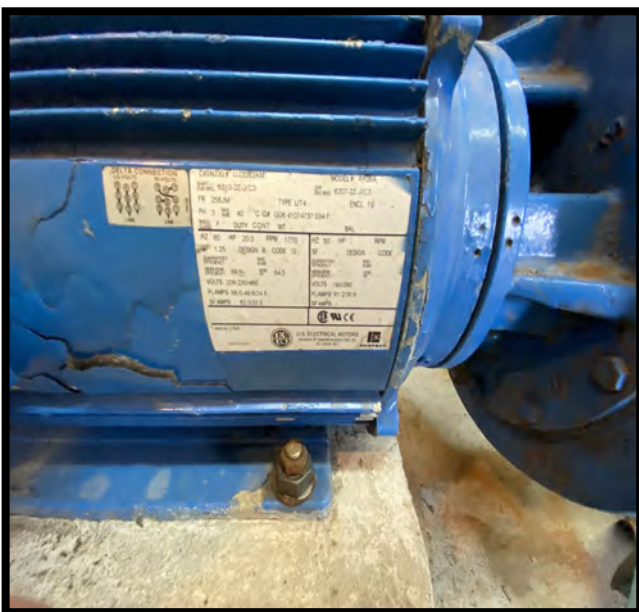
**LEISURE POOL PUMPS AND MOTORS**

Pool pump casings should also be supported via a concrete housekeeping pad. The red arrow in the picture on the upper left indicates where concrete support is required. This is typically a manufacturer's recommendation.

There are minor cosmetic issues with the outer coating of the motor and pump housing, which should not impact the function of the motor or pump. However, the interior wetted parts for pool pumps are typically fusion-bonded epoxy coating on all wetted parts to protect pump internals from corrosion, including pump volute interior and complete pump impeller. The thickness should be 8 to 12 mils (heavy film). Coat parts as recommended by the manufacturer. Provide primers if required to resist chlorinated water <10 ppm. Coating shall be Scotchkote 134 manufactured by Fusecote or approved equal. This coating often wears out over time and needs to be replaced. A clear indication of re-coating is rusty water draining from the volute housing during seasonal start-up.

Install concrete pump volute housing supports.

Epoxy coat or replace the concentric reducers on the discharge flange of each pump.

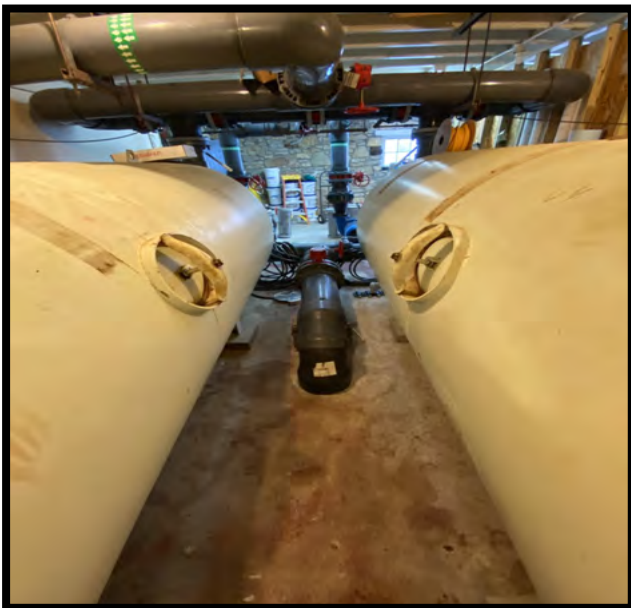
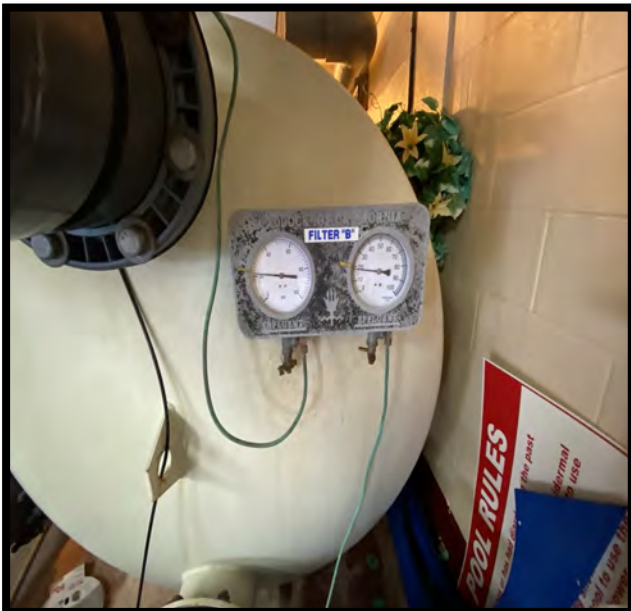
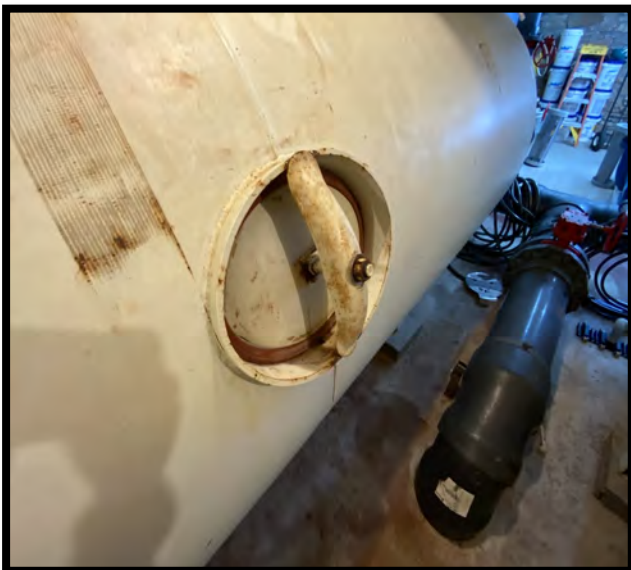
### **LEISURE POOL FILTRATION SYSTEM**

The filters appear to be in good condition with minor cosmetic /surface blemishes. Minor surface rust along with corrosion and weeping trails around the filters indicate future maintenance will be required.

As noted above, the manways are showing the most significant wear. It is recommended to recoat or purchase new manway clamps. Recoating should comply with the manufacturer's recommendations. Further, the manway gaskets should also be replaced. Additionally, it is recommended to have extra manway gaskets on hand in the event the replacement need is immediate.

Remove filter existing sand and install new filter sand.  
*Estimated Cost: \$7,800*

Install new manway gaskets and recoat manway pressure clamps.  
*Estimated Cost: \$1,800*

Recoat the exterior coating for each filter. Please follow manufactures recommendations for the coating material.  
*Estimated Cost: \$16,000*

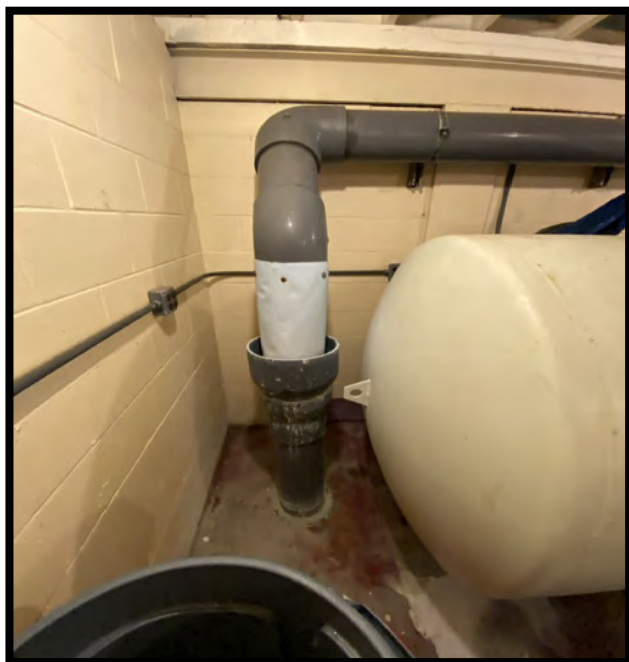
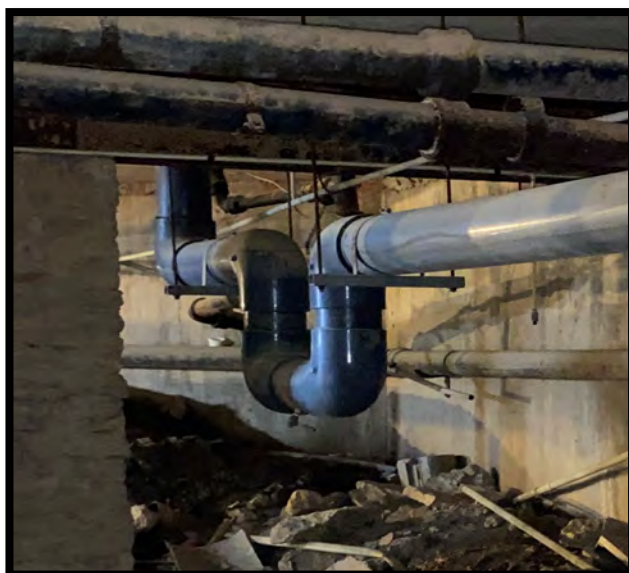
**LEISURE POOL BACKWASH SYSTEM**

The current filter backwash system discharges into a funnel directly behind the west filter (right filter if facing the filters). The backwash flow rate is approximately 820 GPM. Currently, no flow meter is installed on the backwash line, which should be in place to verify flow.

From the discharge funnel receiver, the backwash wastewater is routed to the basement via a 10" discharge pipe. The pipe is routed to the west with a p-trap centrally located (center picture) to a manhole located on the west side of the building. The invert elevation of the backwash discharge pipe in the manhole is "above" the invert elevation of the sewer discharge pipe from the building. To compound this issue, the manhole discharge pipe routed to the sewer main on Elm Street, and the pipe is only 8" in dia. Therefore, if the flow exceeds allowable flow for the 8" pipe leading to the sewer main (approx. 468 GPM @ 3 fps), the sewer header to the building backs up and overflows the toilets.

Install a new impact flowmeter on the backwash header.  
*Estimated Cost: \$200*

Install a new sewer discharge line from the building to the sewer main that can handle the required flow without backflowing into the building.  
*Estimated Cost: \$80,000*

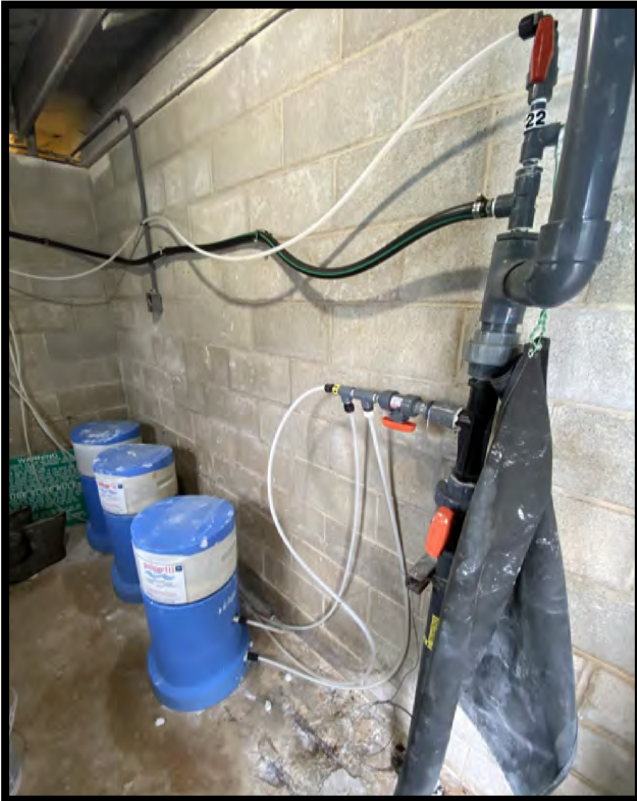
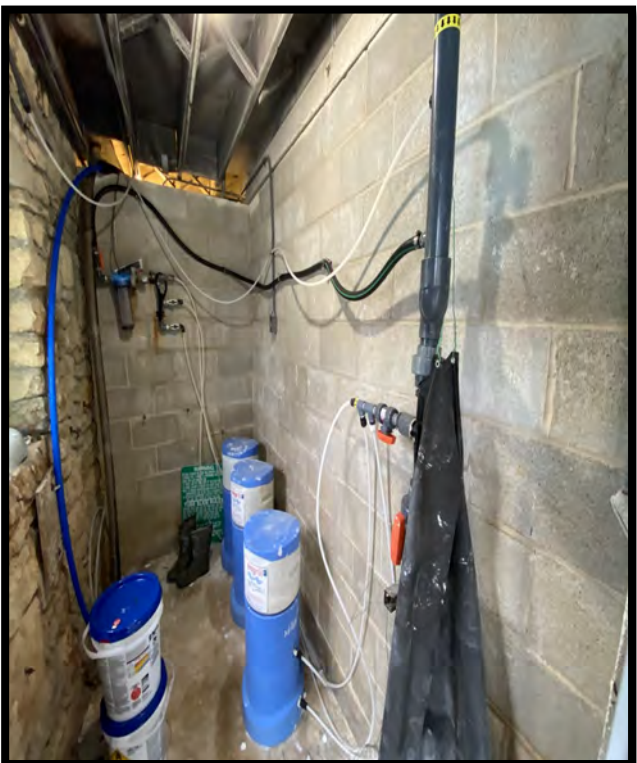
**LEISURE POOL CHEMICAL TREATMENT SYSTEMS**

No pH control system was found during my review. The pool operator added muriatic acid to the pool water by adding acid directly to the pool water at the edge of the pool.

No automatic chemical controller was found. An automatic chemical controller is required by Indiana Public, and Semi-Public Swimming Pools Rule 410 IAC 6-2.1-30.

Install a new automatic chemical controller with a flow cell linked to the recirculation pumps and Sch 80 PVC bypass piping.
