Isle of Man Railways

Investigation Report

Derailment of Manx Electric Railway Tramcar number 16 on the 16th July 2021

29th August 2021

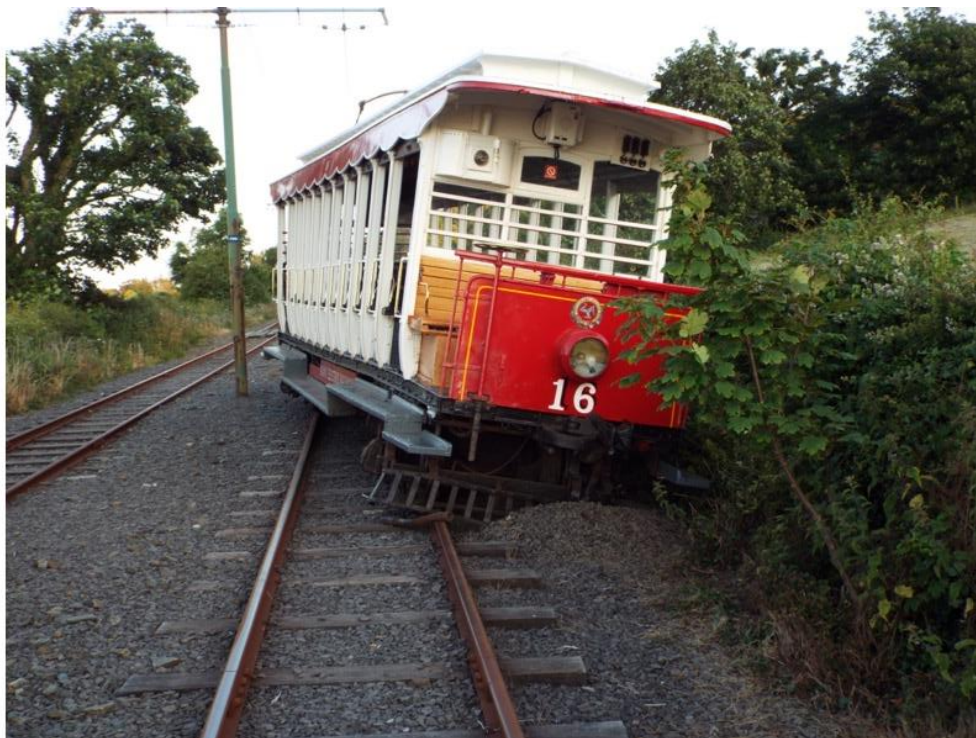
Figure 1. Car 16 following derailment

On the 16th July 2021 a scheduled Manx Electric Railway passenger service formed of tramcar number 16 without a trailer car left Derby Castle for Ramsey at 17:40. In the vicinity of traction pole number 797 between Dreemskerry Farm and Lewaigue the car derailed to the land side at 18:40, all four wheels of the leading truck leaving the rails. The car came to a stop in a ballast shoulder with the front end leaning into the landside hedge just after pole number 799, the landside wheels were in the cess and the other two wheels were in the three foot hard against the landside rail.

Evidence at the site of the derailment showed that once the left hand wheel had climbed over the head of the rail the car ran along the landside rail on the traction motor casing. The right hand wheel then striking a check rails at Dreemskerry Farm occupation crossing and the second axle derailing.

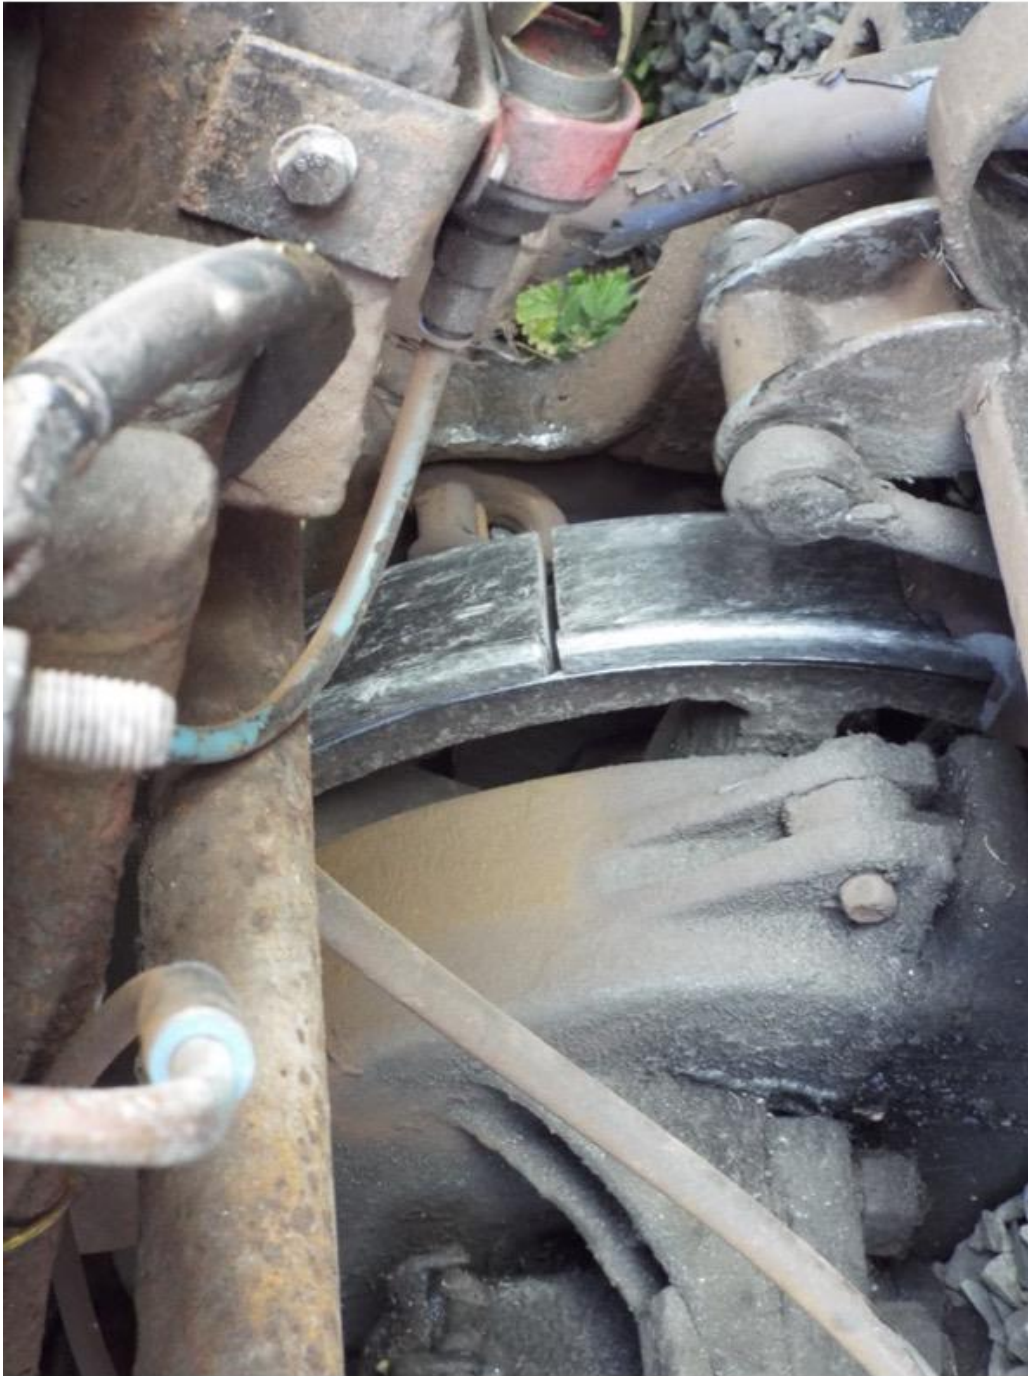
Figure 3 Fractured tyre

The tyres were all worn well below any recognised limits. The tyres on the leading axle of the leading truck were an average of 25 mm thick with a loss of conicity across the tyre. The second axle tyres were approximately 28 mm thick, again with a loss of conicity.

There was a clear brittle fracture in the leading axle, left hand side tyre as shown in Figure 3 below:

The thin tyre and lack of conicity, together with witness marks from the wheel centre rotating within the tyre can clearly be seen.

The immediate cause of the derailment was a broken wheel tyre on the left hand side of the leading axle of the car that was prevented from rotating by the brake block whilst the right hand tyre continued to rotate leading to significant lateral forces that allowed the left hand wheel to climb over the head of the rail thereby derailing the leading axle.

The tyre had suffered a brittle fracture over its complete width allowing it to move on the wheel centre. The fracture had probably occurred when the wheel struck an expansion joint on leaving Dreemskerry. When the brake was applied on the following gradient the brake shoe struck the fracture and was itself fractured by the rotational force. The brake shoe was then held by the crack in the tyre and the tyre rotated on the centre. The broken section of the brake block had been found some four pole lengths in advance of the point of derailment.

A tyre that was worn below acceptable limits leading to hardening of the steel and lack of ductility.

1. Steel gauges for measuring tramcar wheel profiles should be procured. Staff should be thoroughly trained on wheelset inspection and the use of relevant gauges. Maintenance and safety limits for wheelsets used on the Manx Electric Railway must be defined (Some applicable limits and examples of gauges are set out in British Railways Standard MT288).
This recommendation should be completed as soon as reasonably practicable

4. All vehicles on all the railways that have composite tyred wheels should be subject to a daily wheel tap. *This should begin with immediate effect.*

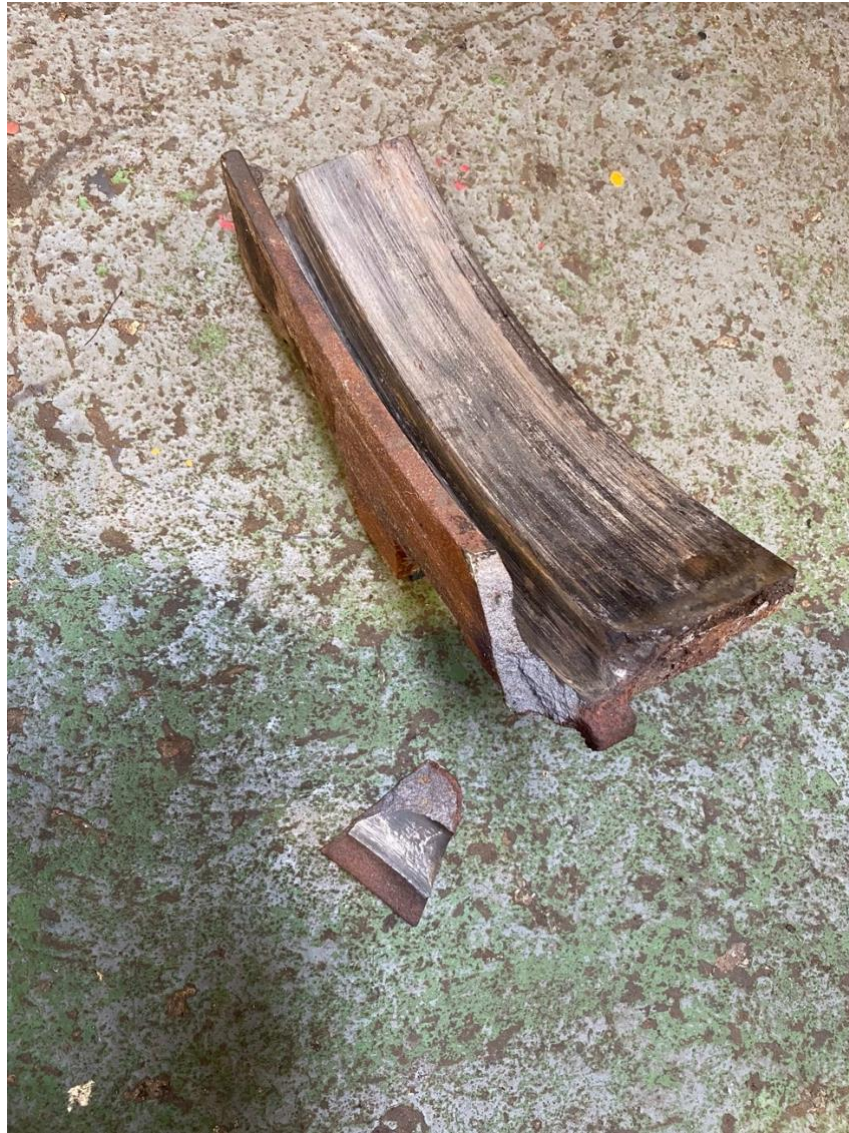
Figure 4 brake block from the leading axle, left hand side together with section recovered from the track in advance of the point of derailment.

Figure 4 shows the brake block and fractured section of the block. The fractured section was found about four pole lengths in advance of the point of derailment. The brake block was worn but was of adequate section to provide efficient braking.

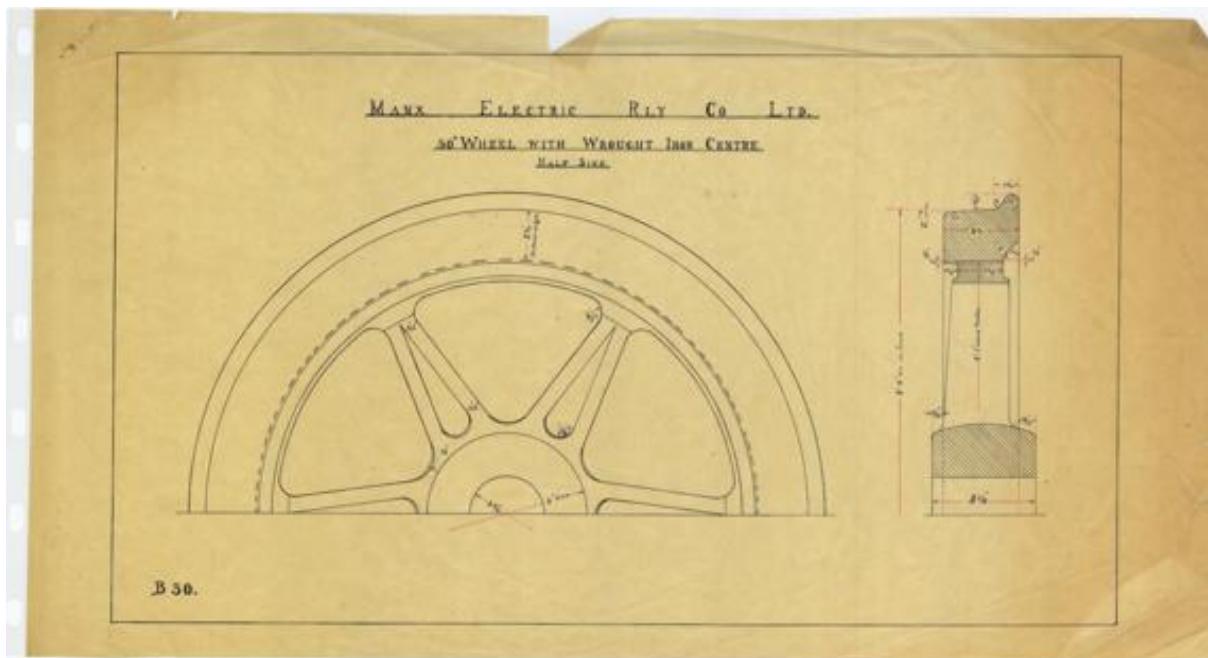
Figure 5 Tramcar wheel and tyre dimensions circa 1930

The design of the tyre registration on the wheel centre is unusual having sharp corners and potential stress raisers.

The drawing indicates that the tyre thickness when new was 2.5 inches (63.5mm).

The tyres on the leading axle of the leading truck were measured at 25mm thick. The tyres on the second axle were 28mm thick.

The best practice standard for wheelset treads and gauging is the former British Railways standard MT288, which gives a minimum scraping thickness for light weight vehicles of 30mm.

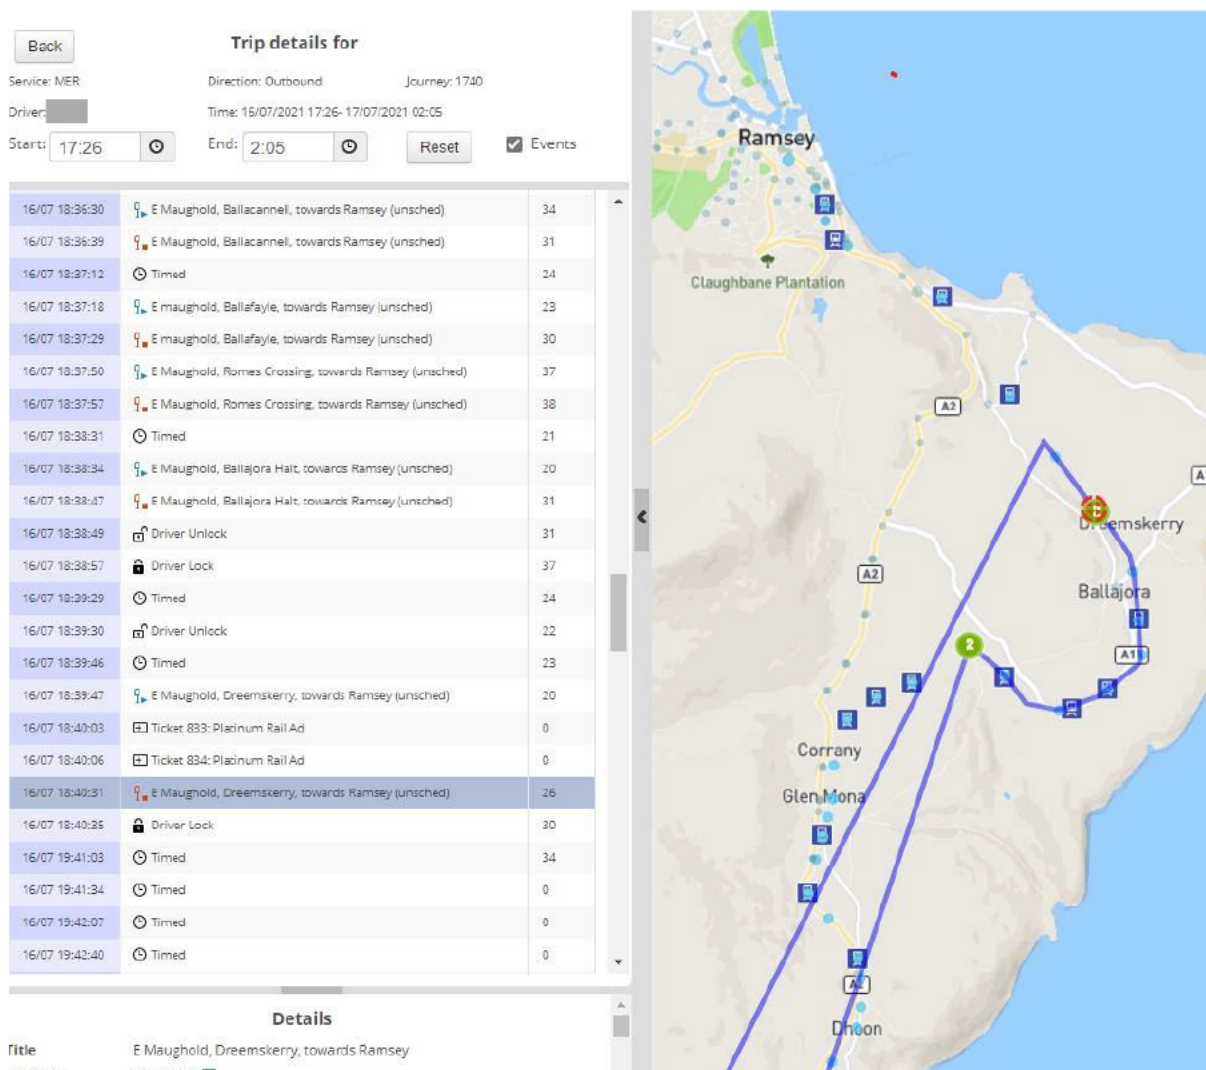
Figure 6 Ticketer graphical output (note: the graphical output is only showing the journey between Ballacannell and the point of derailment, the two straight blue lines should be ignored.)

The speed output in figure 6 is in kph, the car derailed at 34kph (21mph).

From the full journey output data, it can be seen the car was consistently driven below the maximum speed limit of 25mph (40kph).

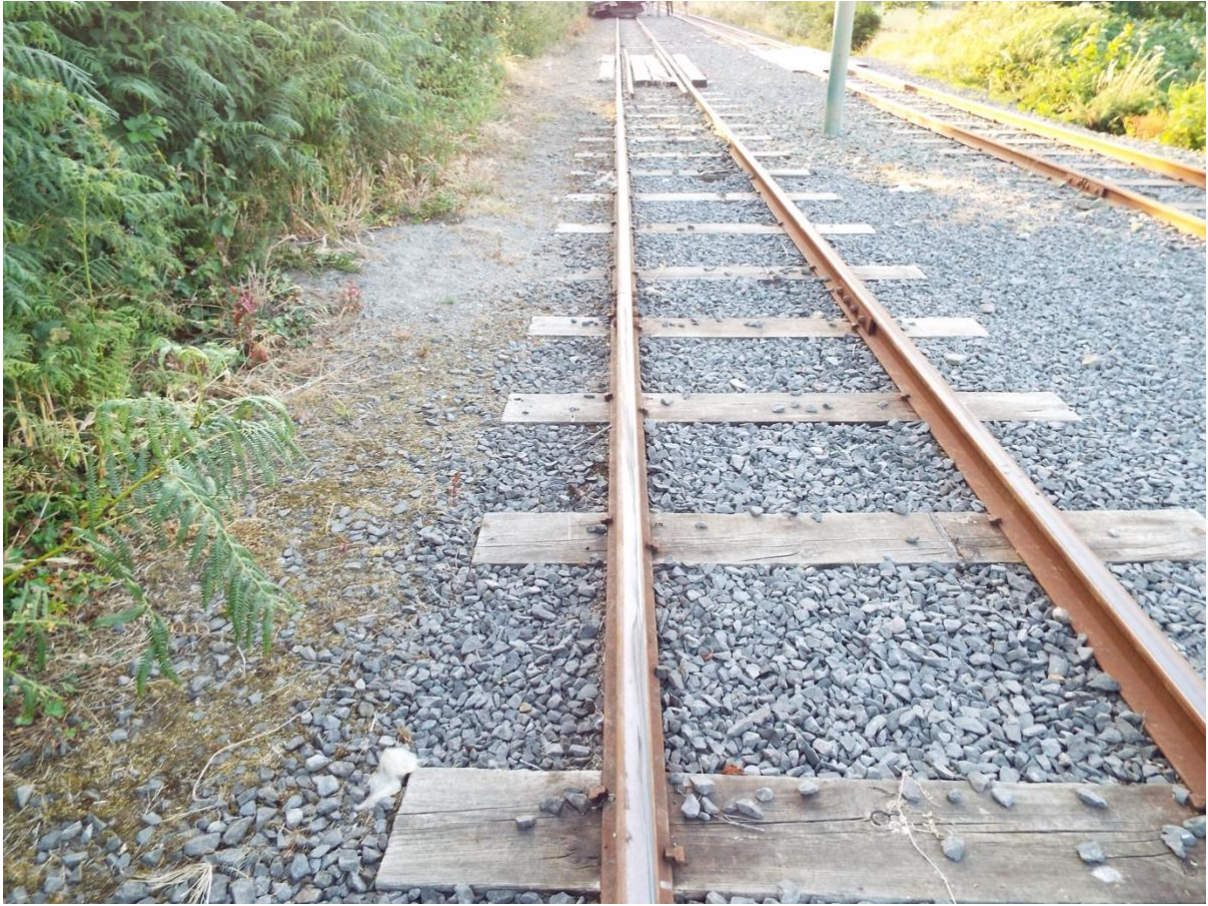
Just after the point of derailment showing marks from the motor case on the left hand rail head and scoring marks on sleepers from right hand leading wheel.

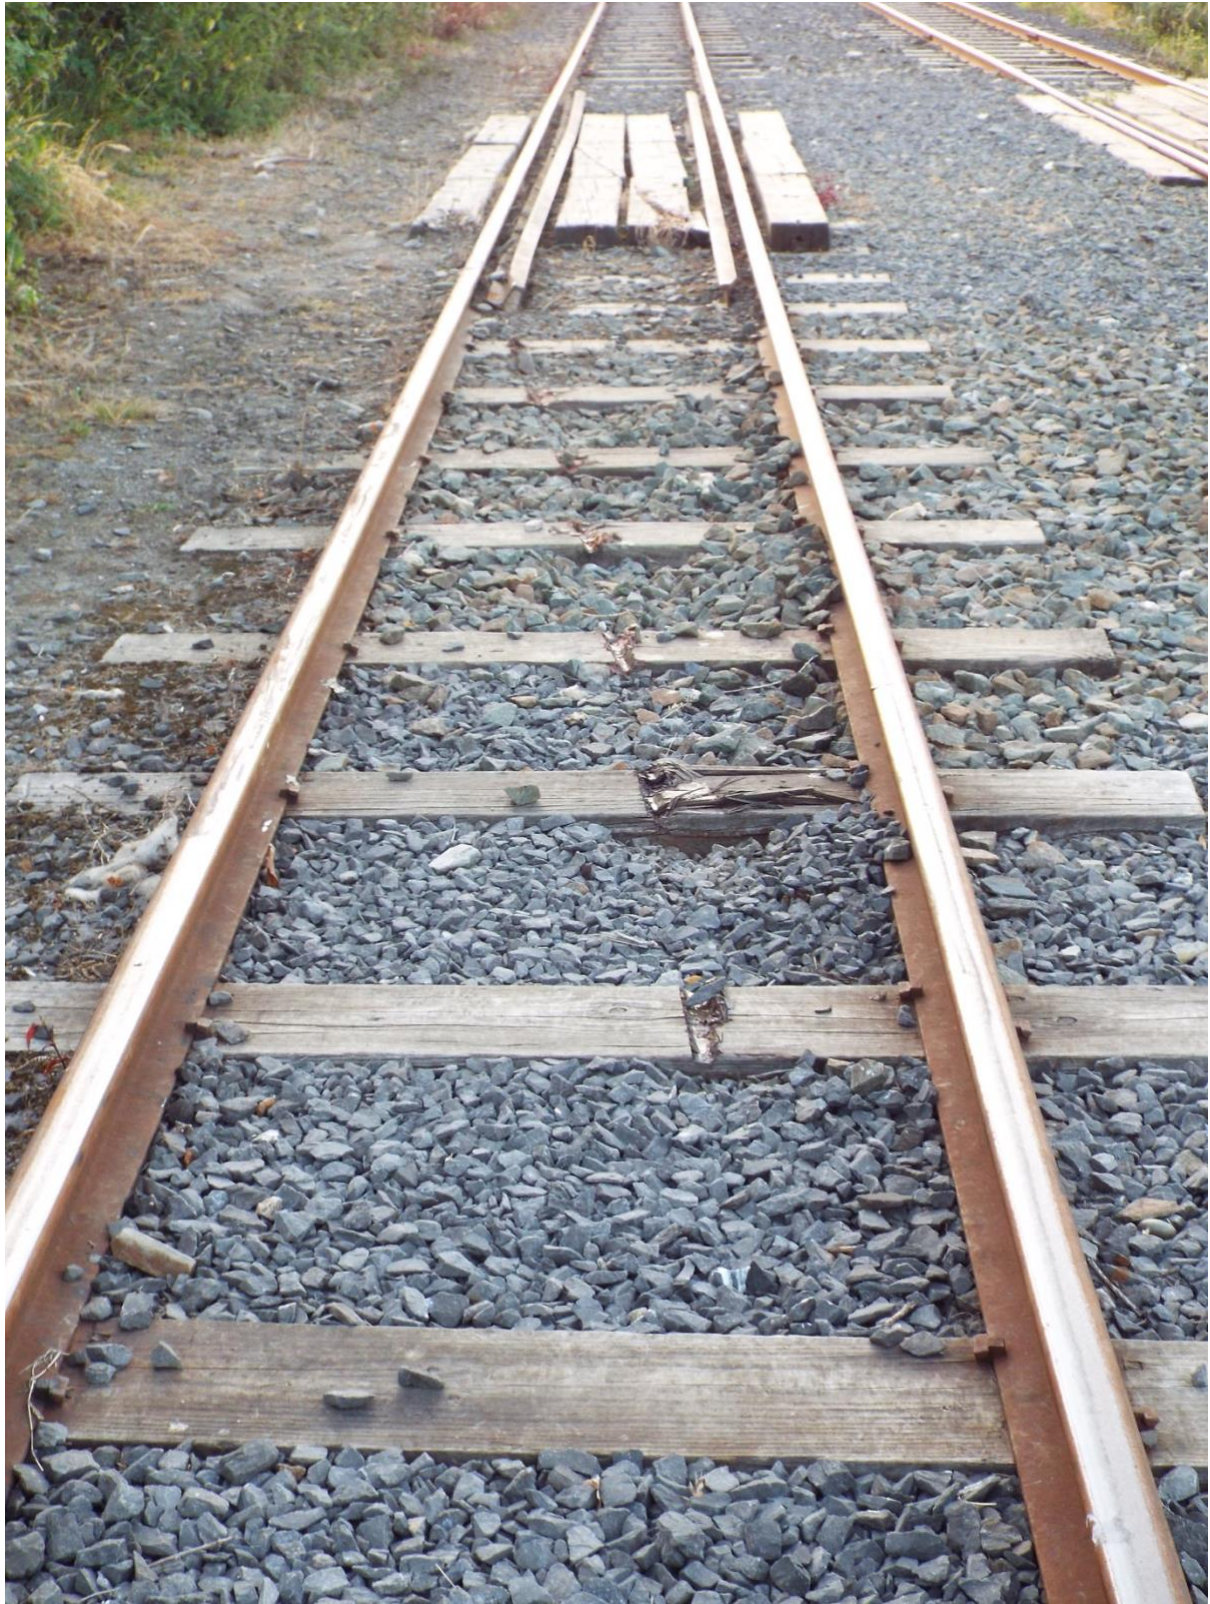
Right hand leading wheel contacted the check rails at the occupation crossing for Dreemskerry Farm. Second axle derails.

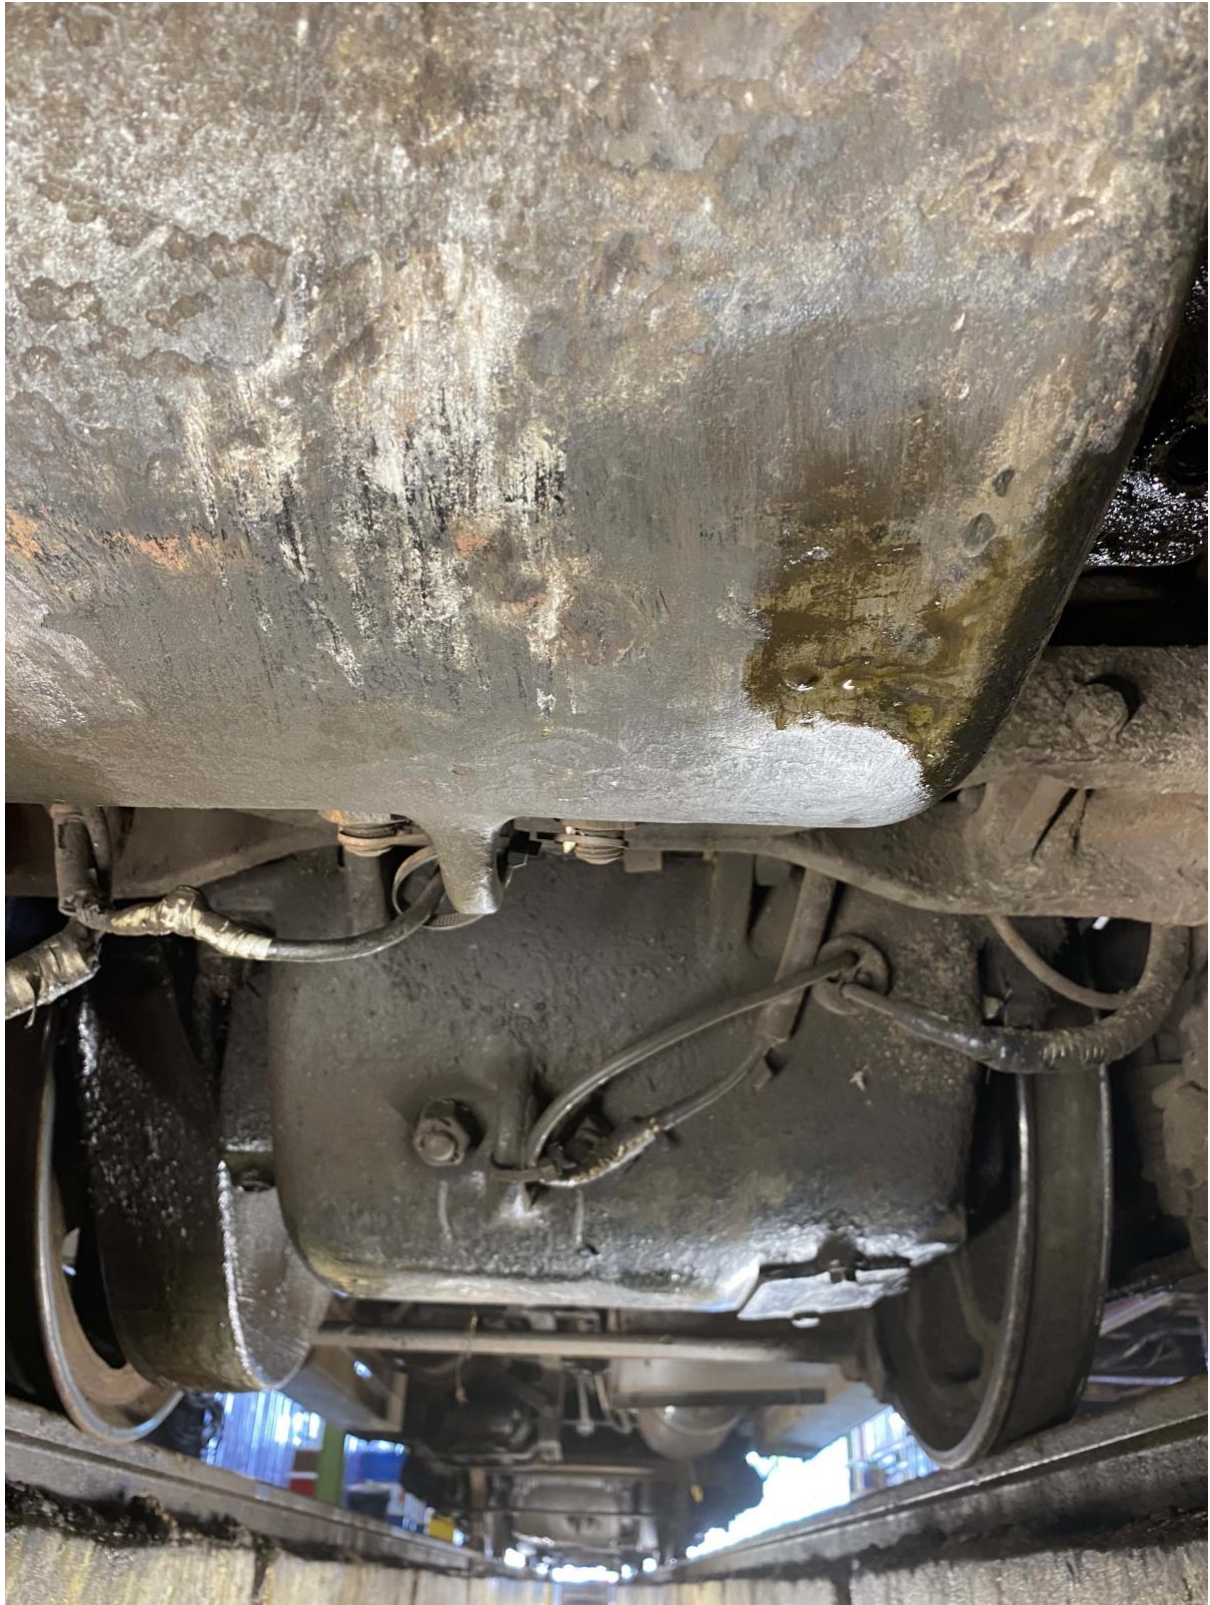
Marks on motor casing from contact with the rail head

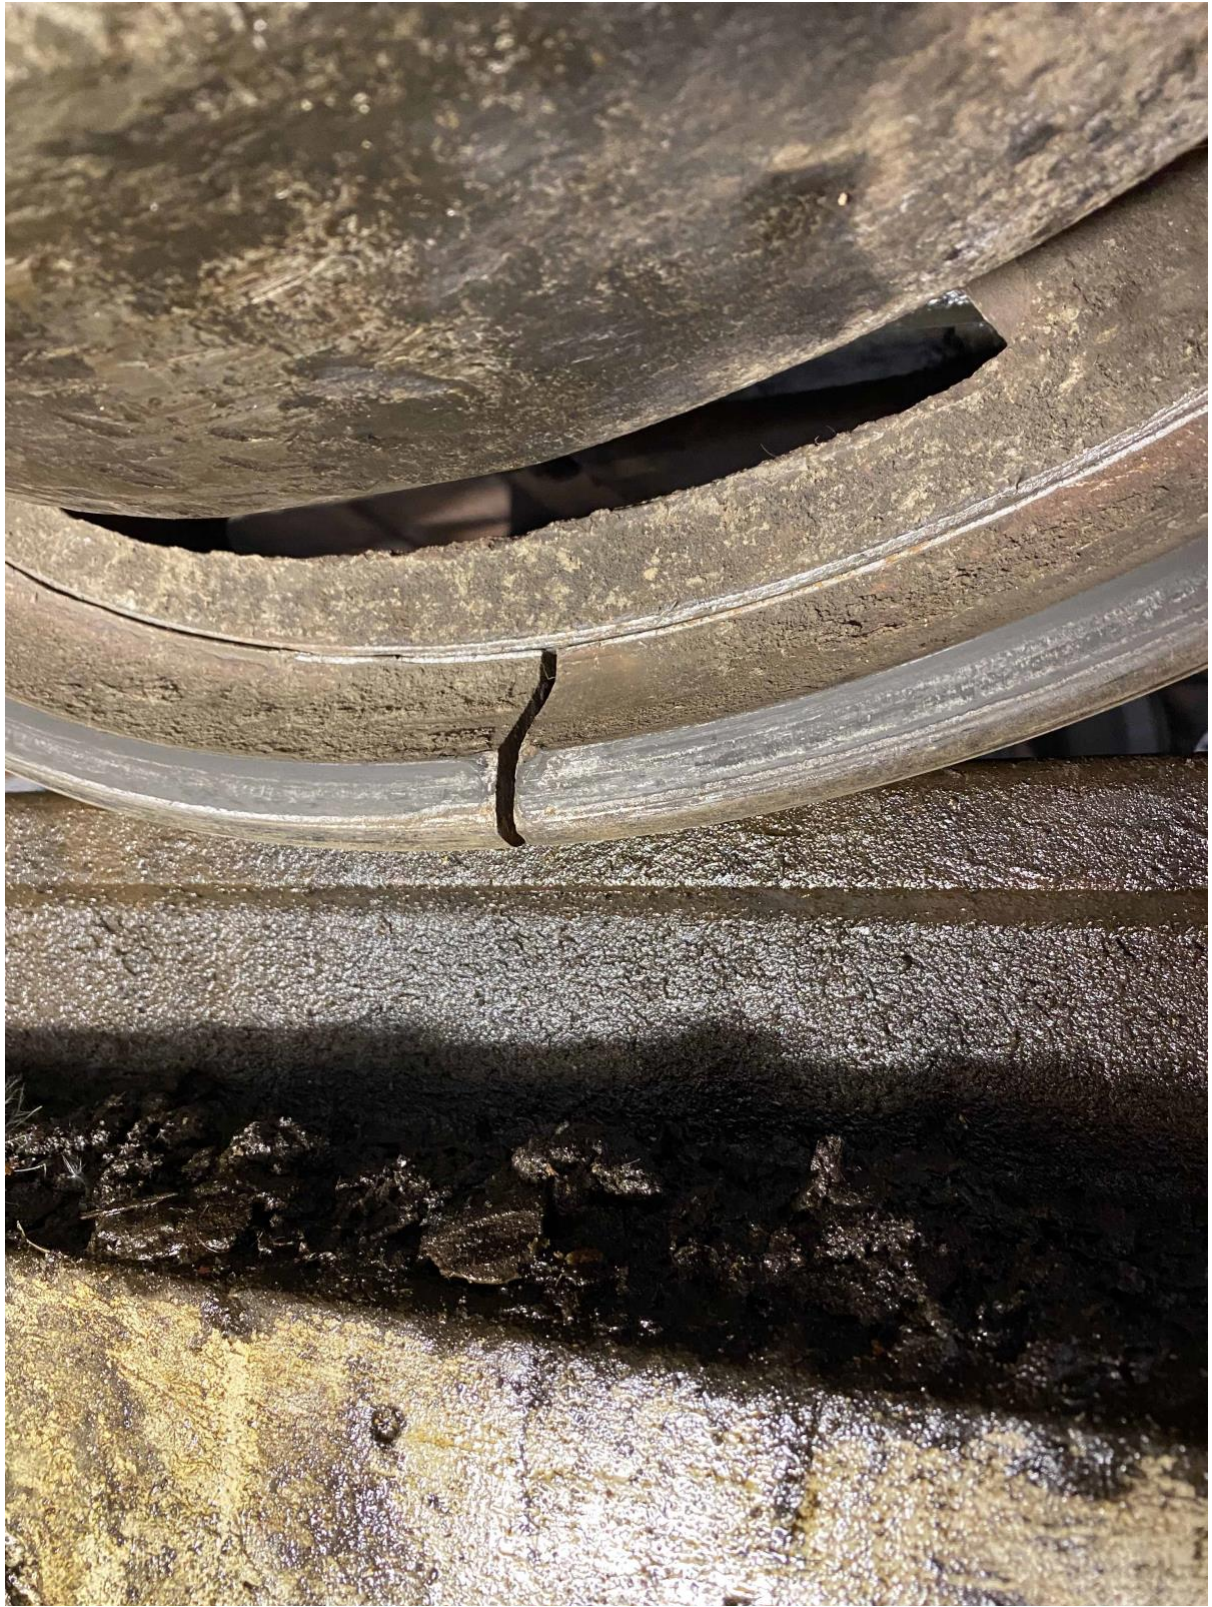
Cracked tyre and witness marks of rotation.

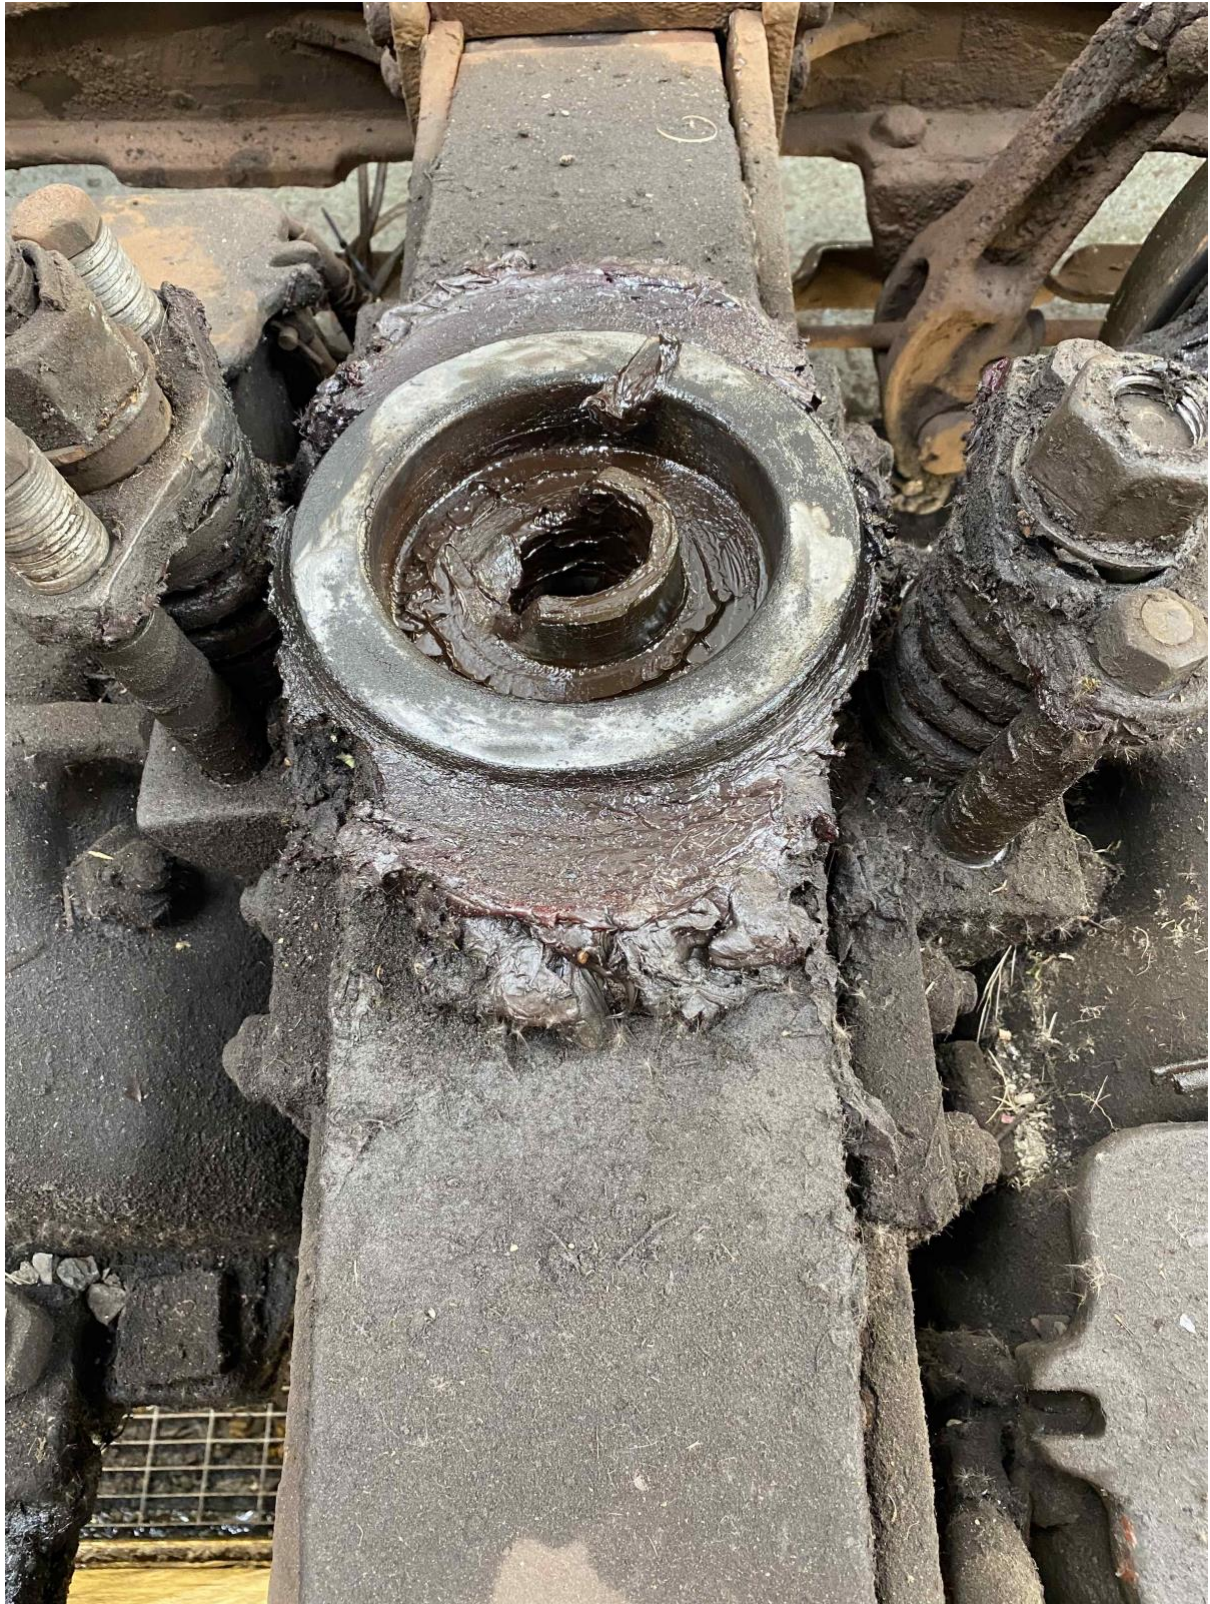
The truck centre plate casting around the front face where the centre pin locates was fractured. This appears to be an historical fracture, possibly due to the flat centre plate that would not permit the truck to travel smoothly through vertical track curvature in combination with horizontal curvature.

Broken centre casting. Note also poor maintenance practice of using washers instead of correct length studs on traction motor reaction springs.
