CABINET OFFICE OF THE ISLE OF MAN

Laxey Flood of 1 October 2019 Independent Review

Final Report

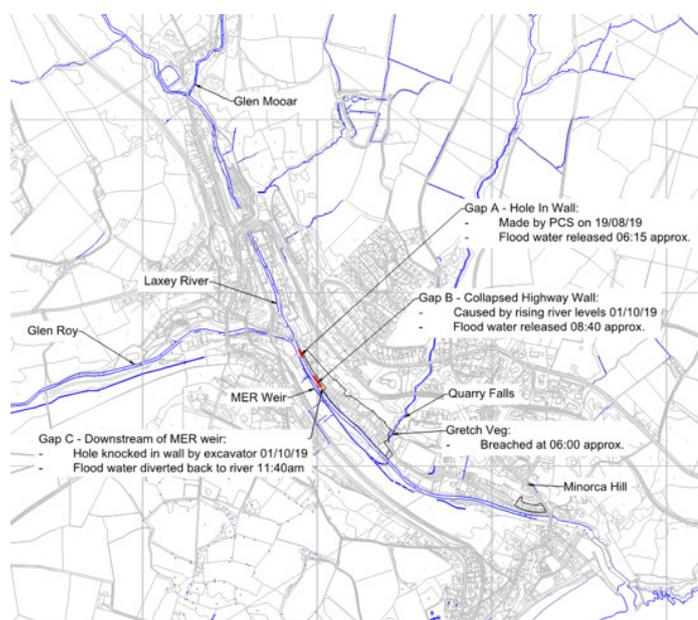
Figure 1 - Map of the centre of Laxey, with labels outlining the events of the 1st October 2019 Flooding.

Several flood mechanisms were at work during this event, triggered by many contributing factors (all timings are approximate). A location plan is included as Figure 1.

Chronologically the first flooding was at 06:00 from Gretch Veg, the stream flowing from Quarry Falls. Potential debris blockages have been attributed to the occurrence of this localised flooding, which affected several nearby properties.

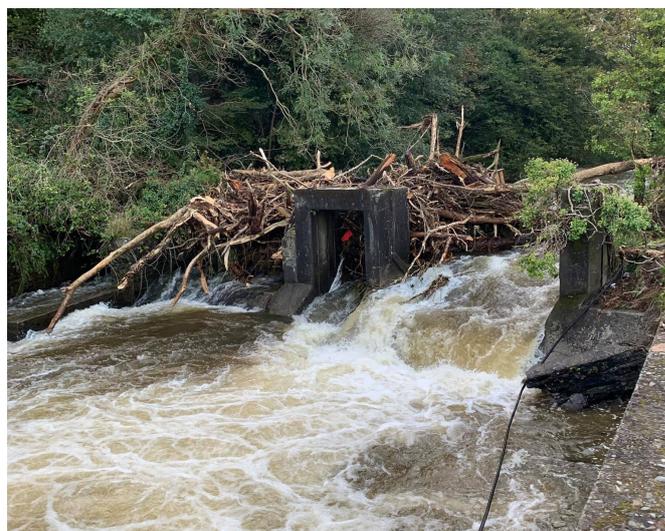
Photograph 2 - Accumulation of debris behind the MER weir on the 1 October 2019

An estimated 50 tons of woody debris, comprising felled tree trunks and limbs of trees, mostly from Laxey Glen on the Glen Roy River was washed into the watercourse and flowed into the Laxey river where it caught and snagged on the superstructure of the MER weir. This caused a major restriction to the combined flood flows of the Laxey River and the Glen Roy, and water levels rose very quickly. In turn the rising flood levels resulted in hydrostatic force on the riverside wall such that a structural failure of the wall over a 20m length occurred. This sudden collapse of the wall resulted in a sudden rush of floodwater onto Glen Road and into properties lying close to the road. It is our assessment and supported by the modelling of this storm undertaken by JBA (1), that it was this particular chain of events that is the reason for the largest proportion of flood impacts experienced on 1 October 2019. We note that reports of the flooding and collapse of the Laxey Harbour Bridge in December 2015 also refer to trapped flood borne debris associated with this event.

RECOMMENDATION 7

We recommend that closer attention is given to addressing the risks of potential debris blockage to vulnerable zones across the Isle of Man.

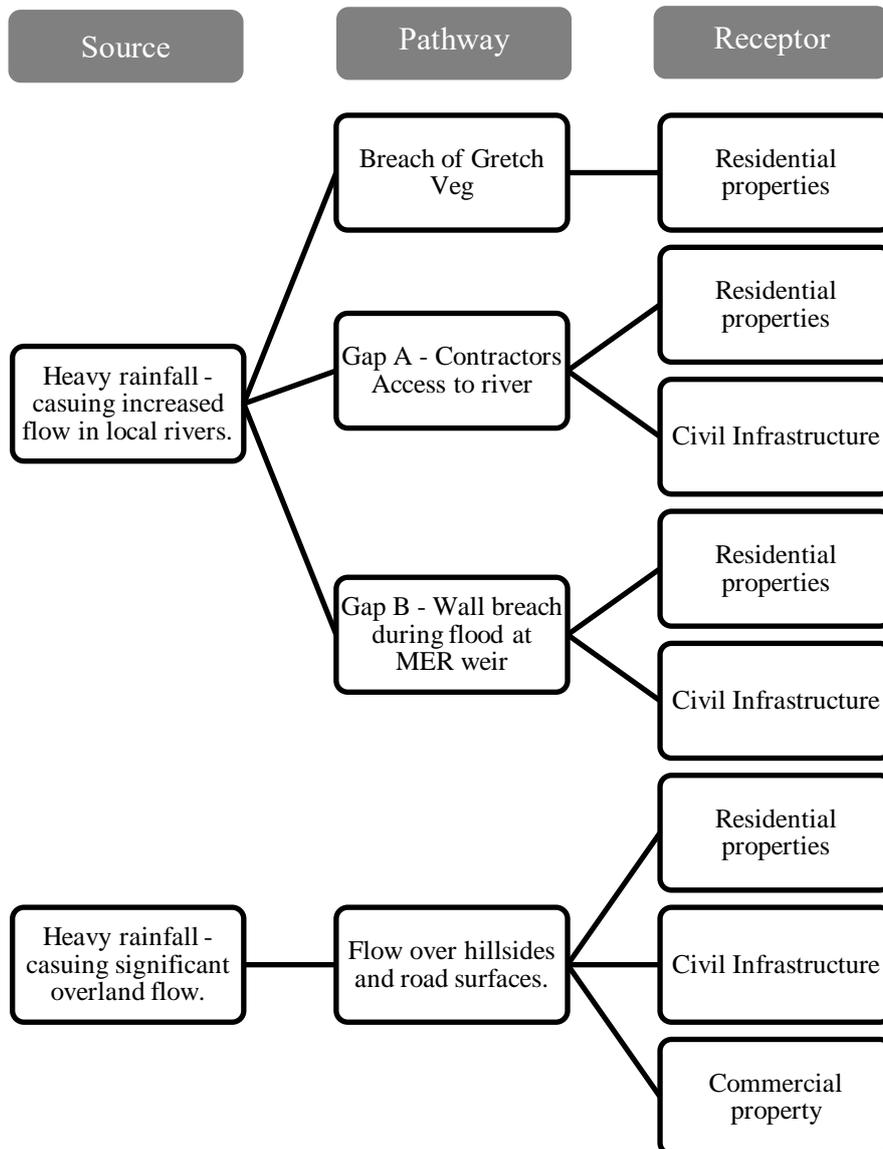
Figure 4 - Source-Pathway-Receptor model for 1st October 2019 events in Laxey.

Flood risk management practice often utilises the Source-Pathway-Receptor model, to consider ways of reducing the risk of exposure of the receptor to the hazard, or reducing the magnitude of the consequences of exposure to the hazard. As in many instances the source and receptors of flooding cannot be readily modified, and the pathways become the element of the model most typically proposed for change or control. Figure 3 shows a simple Source-Pathway-Receptor model for the flood event that occurred in Laxey on the 1 October 2019.

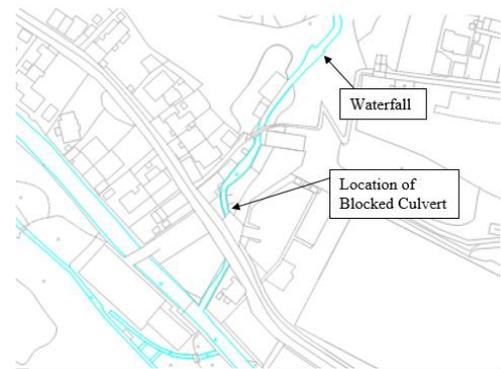
Figure 5 - Location of blocked culvert and waterfall.

The first mechanism of flooding on the 1 October is reported to have occurred from the small stream to the west of Laxey football pitch, known as Gretch Veg. The stream, which flows from Quarry Falls to the River Laxey, is directed through a culvert under the Glen Road. Flood water from this stream is known to have entered local homes at around 06:15, according to public accounts.

The occurrence of this flooding is suggested to in part be due to the blockage of the watercourse. A response to the independent questionnaire stated that dead wood in this stream had been reported to commissioners during summer 2019, without subsequent action. During Arup’s site visit in December 2019, the wall adjacent to the culvert was also found to be partially collapsed, rubble from which was also likely to have caused blockage. The culvert, which is under the ownership of DoI, was deemed ‘not fit for purpose in heavy rainfall’ after inspection on the 2 October 2019¹.

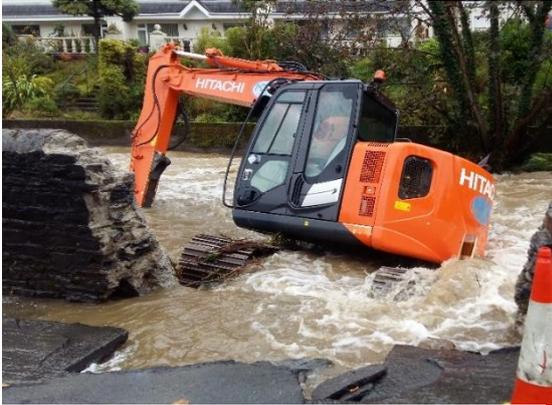
Photograph 4 - Excavator of PCS on the riverside of the hole in the wall (Gap A).

On the night of the 30th of September to 1 October 2019, the excavator being used by PCS was left in the Laxey River adjacent to the hole in the wall (Gap A), as can be seen in Photograph 1. When the river levels began to rise on the 1 October, this hole in the wall became a significant pathway for flooding on to the Glen Road area. However, the JBA Post Incident Review indicates that if the wall been intact during the flood event, then only one property would have been saved from flooding (1).

Anecdotal public evidence and post-event analysis suggest that the presence of the excavator contributed to the volume of flow from the River Laxey (2), through the hole in the wall (Gap A) into Glen Road. Photograph 2 shows the Gap A, and the barrier that was installed to protect it. This Heras style fencing, while serving the function to prevent people and to some extent vehicles from accidentally entering the river, would serve no function in preventing the river from escaping onto the road and towards properties.

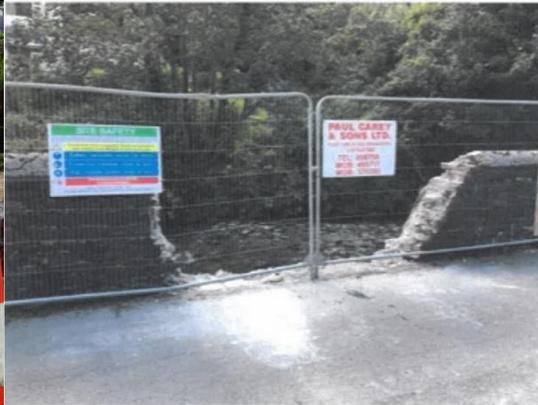
Photograph 5 – Hole in the wall (Gap A) adjacent to Laxey Woollen Mills.

On the 19th August 2019, the contractor removed approximately 4 m of the highway wall adjacent to the Laxey Woollen Mills in order to access the river with a Hitachi excavator.

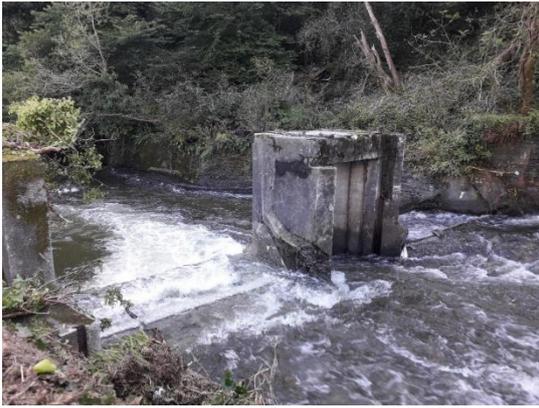
Photograph 7 - MER weir and sluice gate superstructure in the River Laxey, before removal.

On the 1 October 2019, an accumulation of tree debris was noted to have collected behind the concrete superstructure of the MER weir from approximately 07:00 onwards. This blockage caused significant flow restriction to the river and led to the raising of water levels upstream of the MER weir. The water levels are reported to have risen above the level of the wall on the left-hand side of the river, causing river flows to overtop into the road, before a 20 m section of the highway wall collapsed shortly after under the pressure of floodwater.

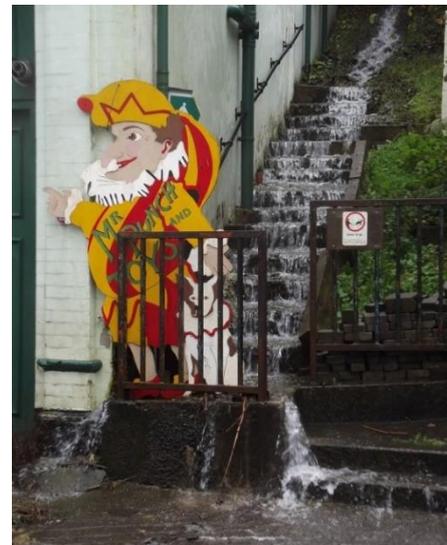
Photograph 8 – Surface water flows, opposite the Garff Commissioners office.

Accounts from Laxey residents describe these surface water flows, particularly in the areas of Minorca Hill and Ramsey Road. Many local residents suggest inadequate or poorly maintained drainage systems are the reason for such significant surface water flooding, as the systems are said to regularly surcharge during non-extreme rainfall events. DoI state that highway drainage is designed to cope with 1 in 5 year rainfall events, which is in line with modern standards (3). Several specific pluvial flood issues that have been described to the Review are detailed in Appendix C1.

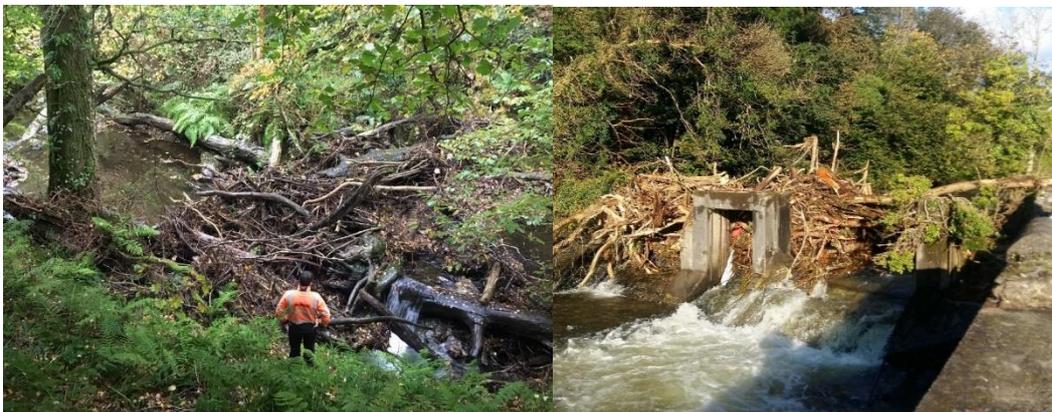
Photograph 10 - Tree-jam in the Glen Roy River in 2018.

The major debris build-up in the Glen Roy River, that is believed to have travelled downstream during the 1 October 2019 flood had existed since October 2018 and can be seen in Photograph 6. This is discussed further in Appendix C2.

Photograph 9 - Accumulation of debris behind the MER weir.

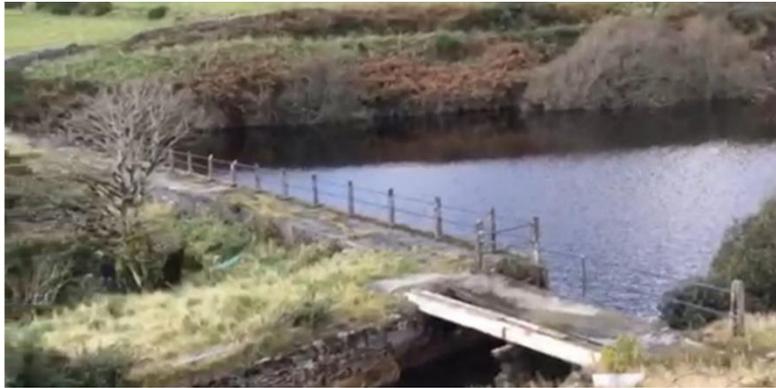
Photograph 11 - Ballacregga Reservoir.

Ballacregga Reservoir is located upstream of the village of Agneash and is understood to have had limited maintenance since it was sold to a private buyer some years ago. With a reported storage volume of over 16,000m³, the reservoir is not subject to Schedule 3 of the Isle of Man Water Act 1991. However, we consider that the reservoir owner has a duty of care to maintain the dam and reservoir to protect those who live downstream from an uncontrolled release of water in the event of dam failure.

The dam was inspected by DoI Structural Engineers, as well as a Supervising Engineer engaged by MUA, after the October 2019 flood and no immediate dangers were noted, but maintenance and monitoring of this type of water impoundment are said to be of concern to the DoI. The Department states it is working with other public bodies to consider the merits of implementing inspections of private dams where there is a risk to the public and the land owner appears unwilling or may not be capable of inspecting and maintaining the structure.

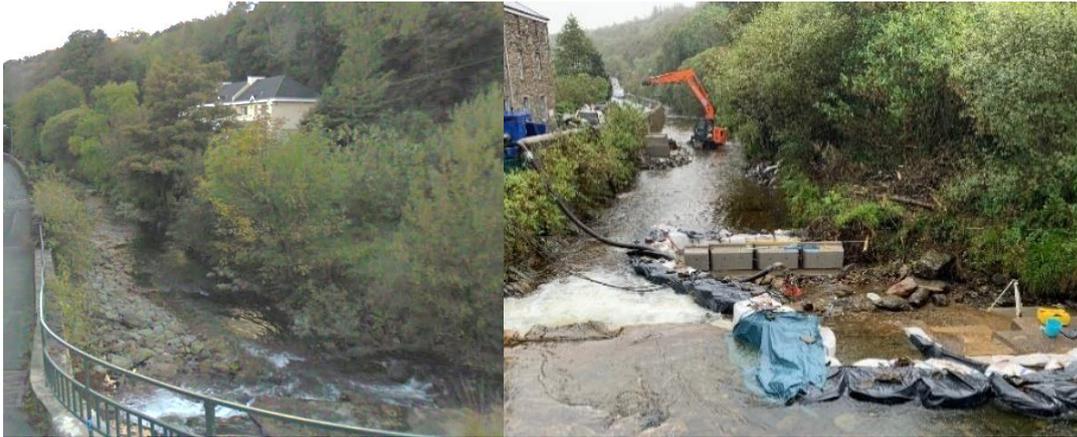
Photograph 12 - Photographs taken looking downstream from Glen Road bridge in 2010 (left) and 2019 (right).

In the past local 'gangs' would be responsible for maintenance of rivers and drainage, and this is said by local residents to have been an effective way of managing the areas, however floods did still occur in this period. Labour costs, developments in machinery and resources cuts mean this method of maintenance is no longer undertaken.

As described in the previous section, there seems to be a limited routine inspection regime to ascertain vegetation management works that may be required. As the flood risk authority, MUA could hold themselves as well as other landowners accountable on a regular basis to these river management requirements. A lack of clarity amongst residents on who is to undertake this maintenance, and how need for it should be reported seems to add to this issue.

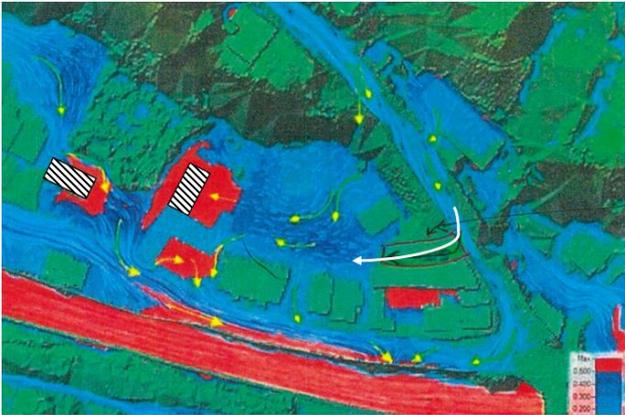
<p>The image below shows modelling outputs completed by JBA for predicted 100-year with 30% climate change flows in the area, provided to the Review by a member of the public. Local knowledge questions the flows indicated by this modelling (yellow arrows) and suggests the real flow path is that shown by the white arrow. The properties shown in black and white are those deemed most at threat, which correlates with the modelling. This information was also shared with MUA and has been forwarded to the modellers in order to make modifications.</p>

<p>Figure 9 - Image showing catchment modelling outputs at the bottom of Minorca Hill area.</p>
<p>The Shore Hotel</p>	<p>The location of the Shore Hotel means it has been flooded by various mechanisms for many years. However, flooding from surface water runoff has evidently increased since the replacement of the Old Laxey Bridge after the 2015 flood event. The change of bridge superstructure from humped to flat has meant that runoff from Minorca Hill now flows across the bridge to the south side of the Laxey River. While a highway drain is installed on the southside at the bridge, accounts state that the runoff largely misses this drain and runs onto the carpark of the Shore Hotel subsequently flooding the basement of the property, as shown in the image below supplied by a local resident who performed an experiment using milk as a dye in the rainfall runoff.</p> <p>During the 1 October event, the Laxey River did not significantly overtop at the Shore Hotel, however the property was flooded. CCTV footage shows how the car park gradually fills with runoff from the road.</p>

<p>Despite this evidence, the basement flooding at the Shore Hotel is likely to in part be due to subsurface water ingress, and tanking on the underground element of the property should be considered.</p>

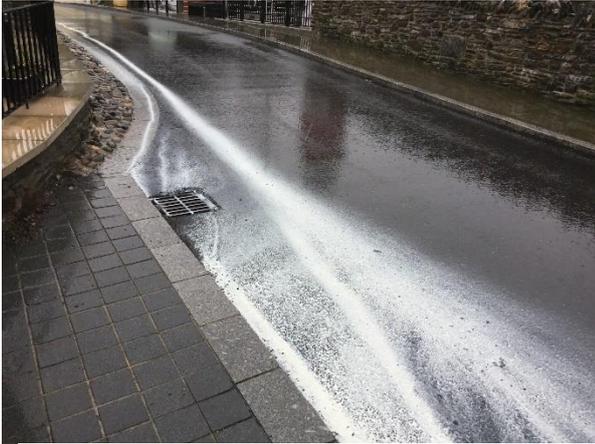
<p>Photograph 13 - Surface water flow over the new Laxey Harbour bridge, looking towards Minorca Hill.</p>
<p>Ramsey Road runoff</p>	<p>Significant surface water runoff from the A2 Ramsey Road and the hills to its north is noted to affect residents of Minorca Vale (several properties heavily flooded), Upper Cronk Orry (1 property flooded) and Ramsey Road Cul de Sac (2 properties flooded).</p>

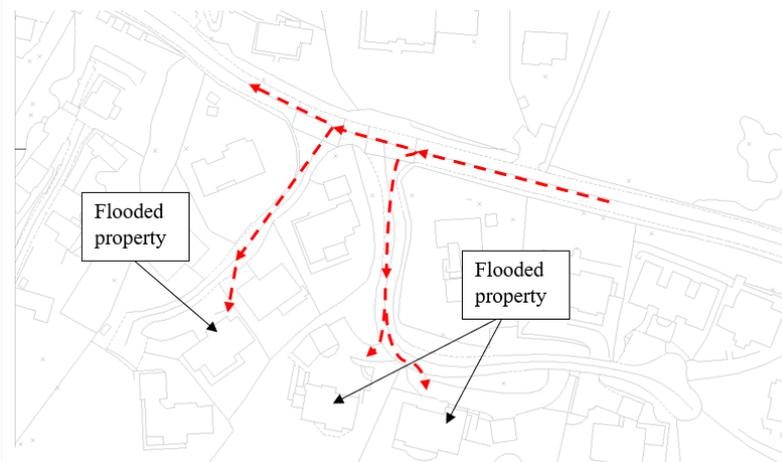
Figure 10 - Image showing flow paths at Upper Cronk Orry and Ramsey Road Cul de Sac

A lack of drainage along a long length of Ramsey Road as it enters Laxey from the east is noted to cause a build-up of runoff flowing down the road. The drainage that is provided further down the hill is said to be inundated on a regular basis. As the flow comes into the residential area, it finds various paths which cause issues to properties. The image below demonstrates flow paths that are known to cause flooding to properties on Upper Cronk Orry and Ramsey Road Cul de Sac. A blocked culvert at the bottom of Minorca Vale is suggested to be the cause of significant issues to two properties there. This culvert was identified during a drain survey in March 2018, but no action is reported to have been taken. Properties on Quarry Road and Minorca Hill itself are also said to be affected by related issues. Reports state that flooding incidences in 2015, 2016 and 2017 occurred shortly after local gullies made been cleared, indicating issues or inadequacies with the systems.

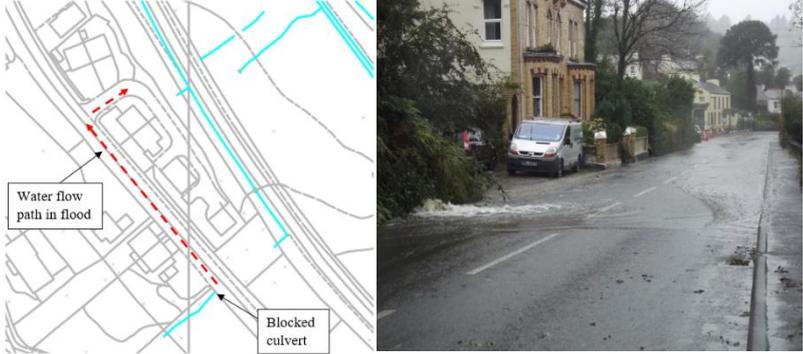
<p>New Road Culvert/Drain</p>	<p>A culvert under the New Road carries a stream from the north. During heavy rainfall the culvert is overwhelmed and causes flow from the stream to instead flow down the road. The runoff's flow path includes diverting down a side street and down the hillside to the Laxey River. On the 1 October this is thought to have caused a landslip above the MER line.</p>

<p>Figure 11 - Image showing flow path on the New Road (left) and photograph of area after heavy rainfall event (right).</p>
<p>Mines Road</p>	<p>The concentration of flow through a concrete culvert under the MER line above Mines Road caused flooding issues to local properties on the 1 October, as well as several times in the past. The flow from the culvert has led to a waterfall, that in heavy rainfall results in a number of tributaries, some of which make their way to residential properties where they have caused flooding issues.</p>

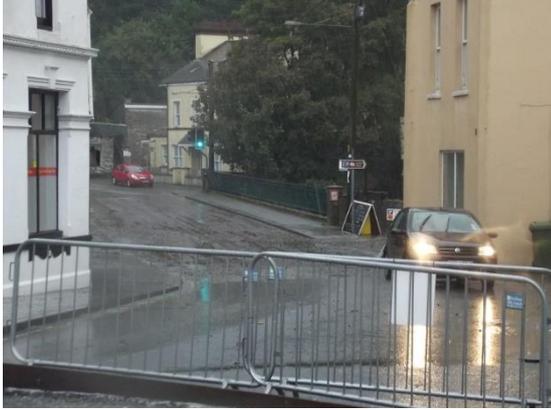
<p>Photograph 14 - Flooding at the New Road bridge, adjacent to Laxey Working Mens Institute.</p>
---	---

<p>Flooded bridge outside working men’s institute always an issue</p>	<p>During heavy rainfall, localised flooding of the New Road bridge often causes the closure of the bridge. As the centre of Laxey is often already severely affected in such events, the village becomes effectively impassable. This can have serious effects on both resident’s lives, and the access for responders to flood events.</p>

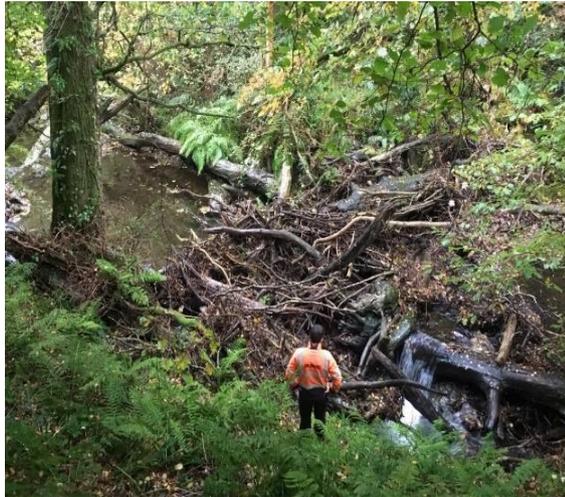
Photograph 15 - Tree-jam in the Glen Roy River in 2018.

The blockage, reported to be creating a waterfall with 1.5m from upstream to downstream, can be seen in Photograph 6 - Tree-jam in the Glen Roy River in 2018.

On the 8th of October 2018, a MUA officer visited the site of the tree-jam.
