# CRYSTAL BEACH POOL RENOVATION

*400 W Vaughn Drive, Madison, IN*

## Condition Summary & Recommendations

*April 11, 2022*

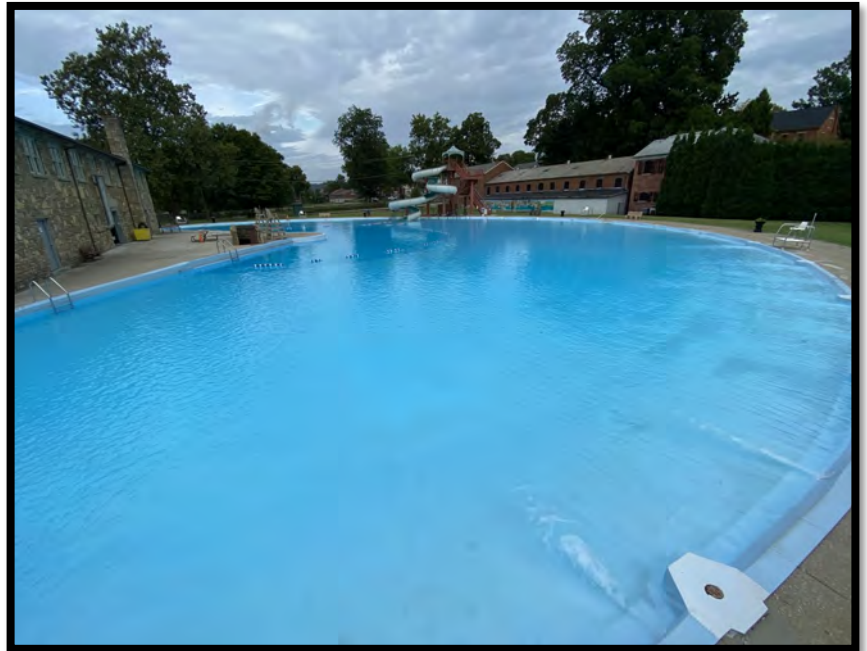
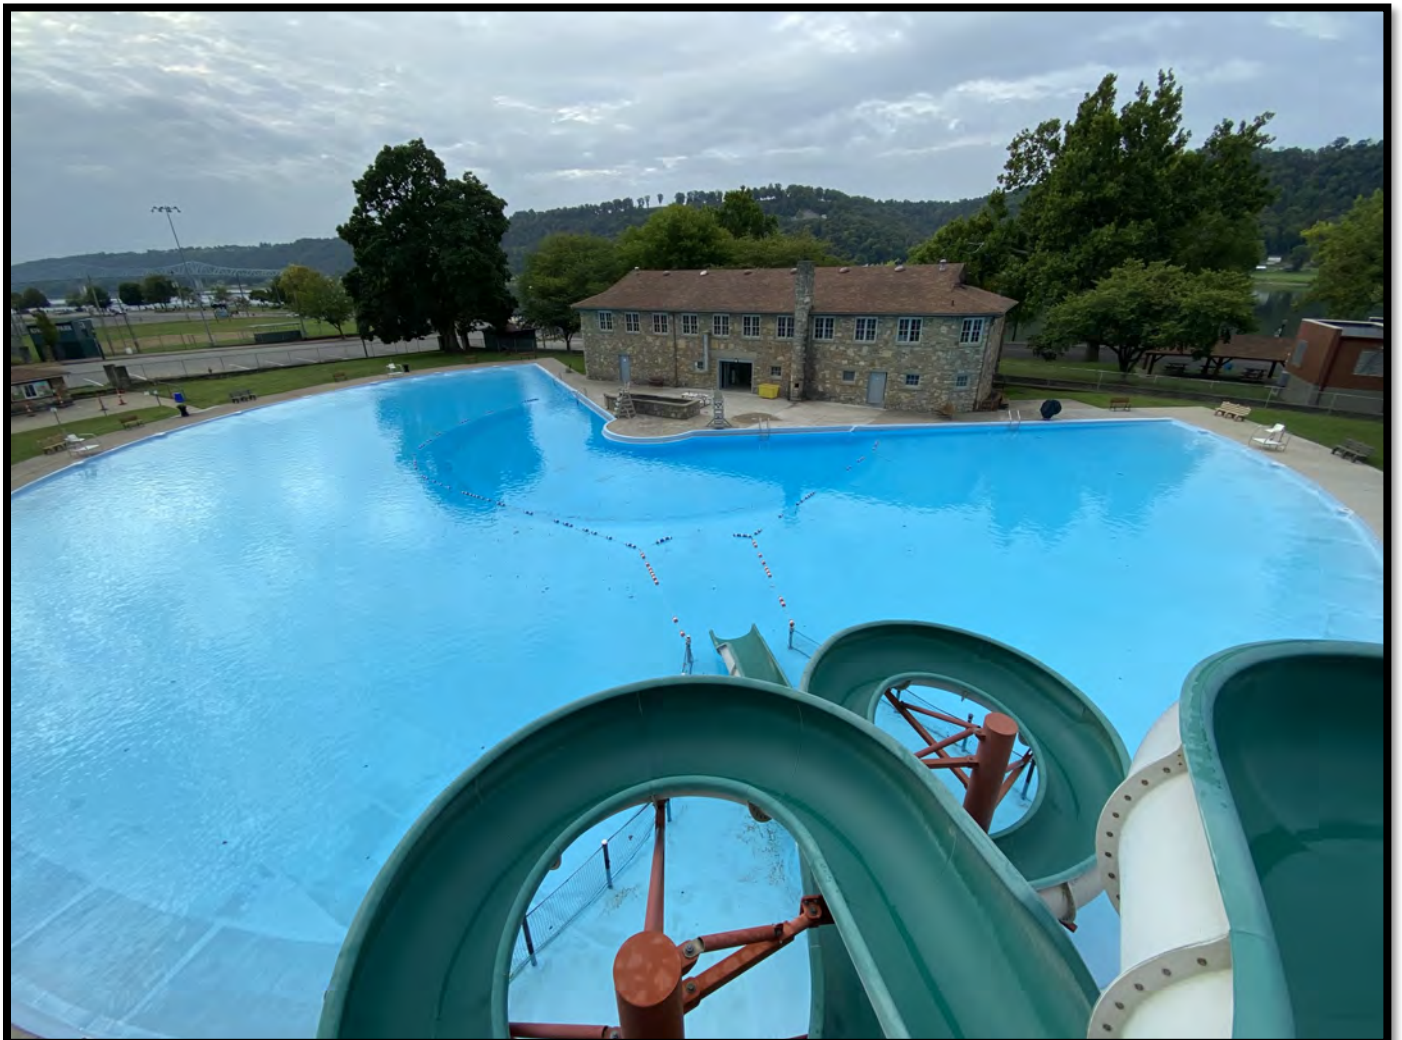
The exposed pool wall located on the south side of the pool within the lower level of the bathhouse had clear signs of the pool leaking. Cracks in the concrete pool wall has water weeping through the cracks. This could be contributed to a fractured pipe, but until the piping is pressure tested, it is unclear where the water is coming from. With the age of the liner and the current condition seen during my inspection, some or all of the leakage can likely be contributed to a failing liner.

Replace the current pool liner with a new liner installed by a qualified contractor.

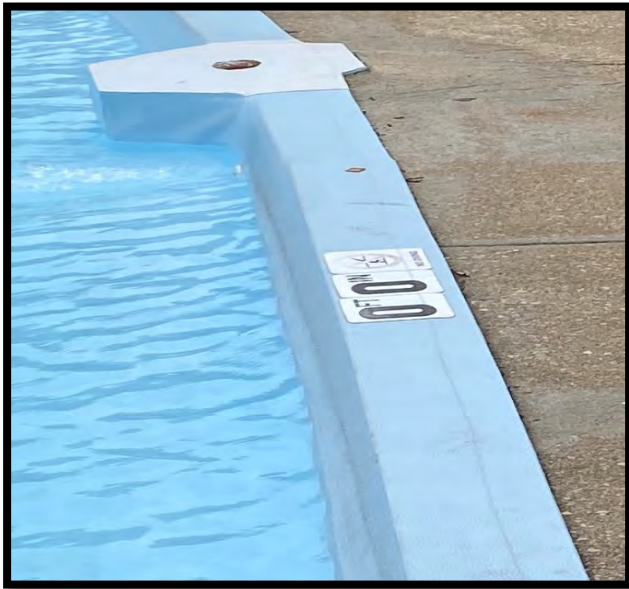
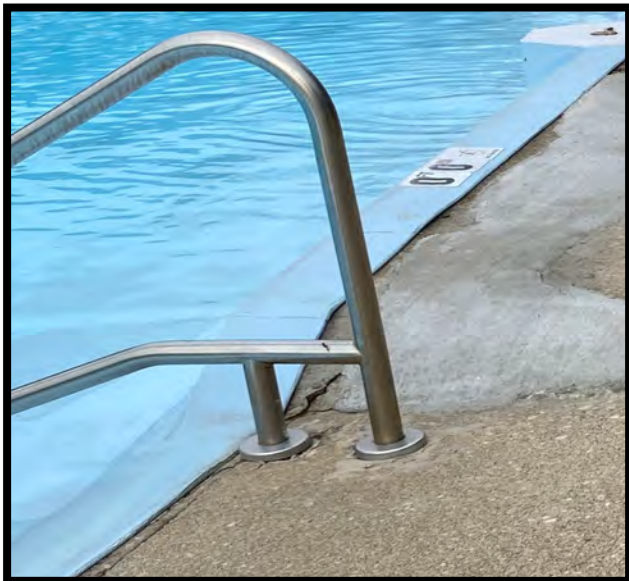
### LEISURE POOL FLOOR SLOPES & DEPTHS

The arc portion of the pool does not have an actual “Zero Entry Pool” as defined by aquatic and health code terms, except for the ramped entryways with rails. The remainder of the arc requires a 6” to 8” step down to enter the water. A proper zero entry is a sloped entry (at a 1:12 slope) where the deck meets the water without a step/ stair riser. There are portions of the arc where the step-down lands in 2” of water and other areas where the depth truly is 0’-0”.

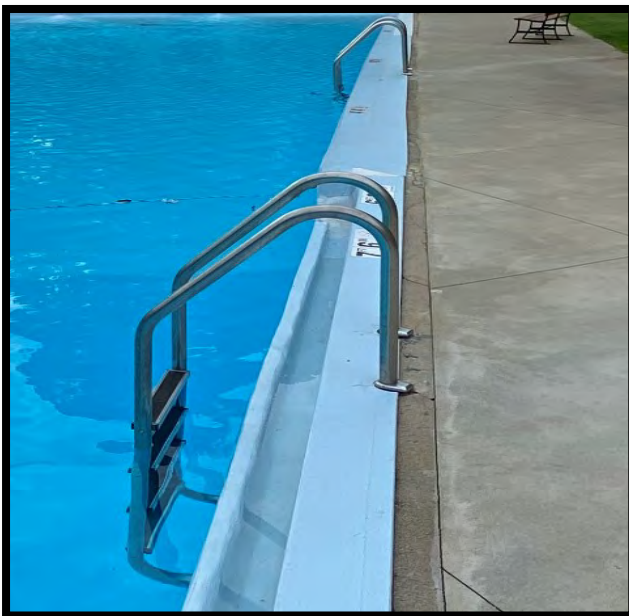
The Crystal Beach Pool structure has numerous issues and concerns. As seen by the pictures to the left, the pool is leaking water extensively, and this is just in the visible area, which is only about 10% of the pool wall. While on-site, the 2" fill line was on for more than an hour. The current pool liner has issues related to its age, as noted on the previous page, so leaks can certainly be contributed to the liners needed replacement. Still, the pool structure is undoubtedly a significant concern. When water weeps through structural cracks in the concrete, the rebar expands, flakes, and ultimately fails. This compromises the pool's structural integrity, thus causing additional cracking and leakage. An assessment by a structural engineer can undoubtedly lend more detailed insight into the structural concerns. Still, ultimately, lateral loads on the pool walls are a concern and a potential safety issue.

Replace the pool structure with new, code-compliant swimming pools and/or spray pad(s).

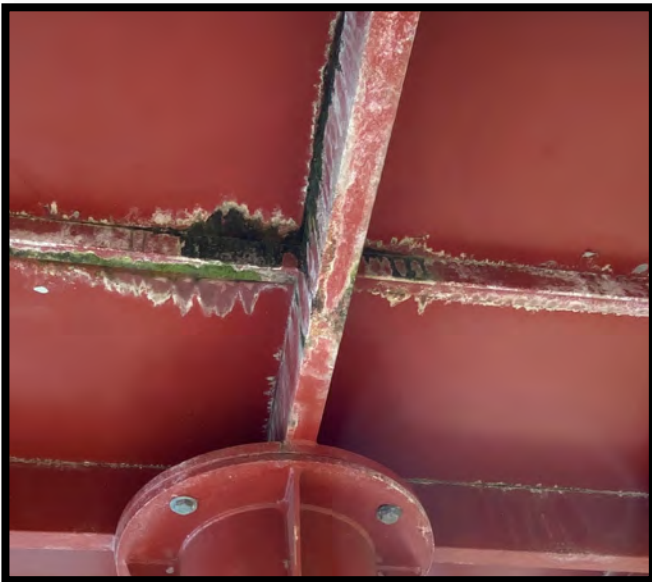
The painted surfaces of the steel support columns, extension arms and ladders, and stair treads are severely faded, but fictionally in good condition. The slide platform is starting to show corrosion at the support beams on the underside of the platform (see picture, lower left). Although this is currently a minor concern, repairs are justified to prevent further corrosion.

Epoxy paint the water slide structural steel
